Common Areas-Description

Harrison West Condominiums-CA-Photos Common Areas-Description View of a leak in the hydraulic line behind the pump at the freight elevator; all such leaks should be investigated and corrected. View of the freight elevator hydraulic pump located in a room adjacent to the parking garage in the tower building. View of the freight elevator hydraulic pump jack located in the pit adjacent to the parking garage in the tower building.

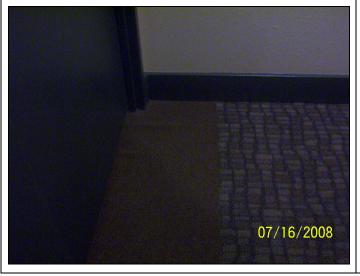
View of the typical hallway common area carpeting serving the units, this one in front of unit #23-F; some of the carpeting is wrinkled at the margins and some seams are beginning to show wear, indicating the carpet was not fully stretched, or has stretched since installation was completed in 2006.

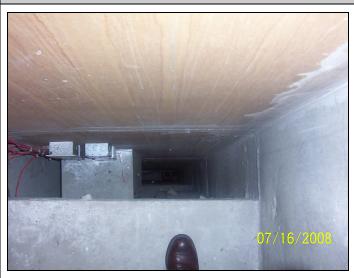
View of the mechanical chase located in a closet accessible from the common area hallways opposite the trash chute shown in the previous photo, at the Subject Property tower building. This chase extends vertically and is continuous through the tower building, is approximately 10" wide and not screened and represents a danger to children if the closet doors are not continuously closed and locked or monitored while opened.

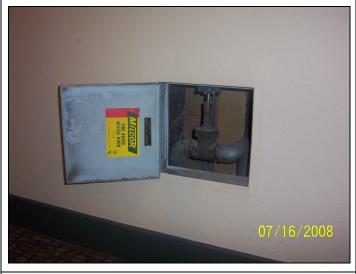
View of the water shut-off valve located in the common area hallways; each valve shuts down the water supply to the kitchen in one unit and the bathrooms in the adjacent unit. The Milcor fire-rated access door panels fail to open by hand operation at most locations tested and should be repaired or replaced. According to management, the valve is located in an exhaust shaft that extends from the 1st floor to the roof and removes exhaust air from unit bathrooms and kitchens.

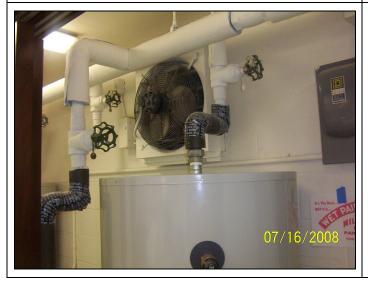
Close-up view of one of the electrical water heaters in the laundry room at level #B-1 in the tower building; according to management, shut-off valves were replaced in 2006. The exhaust fan behind the water heater does not work and needs replacement, according to management.
