| Harrison West Condominiums–CA–Photos | Exteriors & Sitework–Description |

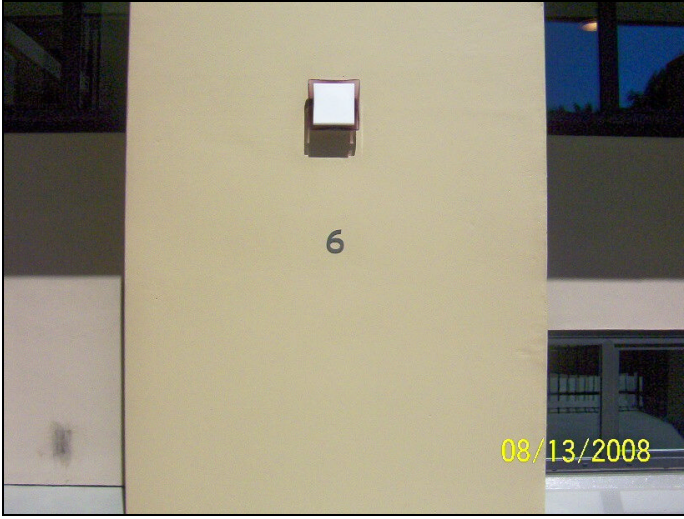
| Harrison West Condominiums-CA-Photos | Exteriors & Sitework-Description |
|---|---|
| | <p>Close-up view of the entry façade at building #3, unit #6 at the Subject Property, looking north; note the damage to the wall surface seen at left in the photo.</p> |

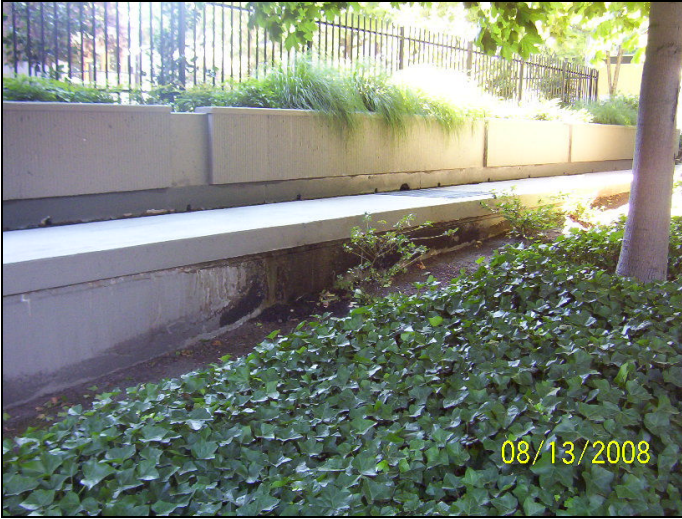
| Harrison West Condominiums-CA-Photos | Exteriors & Sitework-Description |
|---|---|
| <p style="text-align: right; color: yellow;">08/13/2008</p> | <p>Close-up view of the retaining wall below the planter shown in the previous photo; note the presence of water seepage under the top slab.</p> |

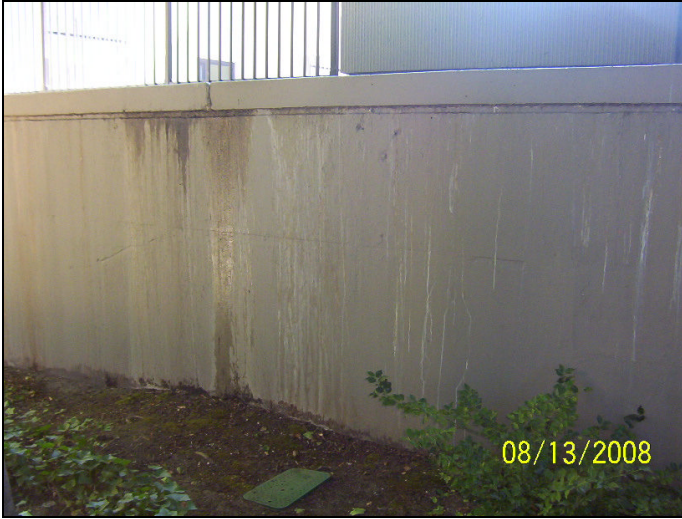
| Harrison West Condominiums-CA-Photos | Exteriors & Sitework-Description |
|---|--|
| | <p>More retaining wall water and efflorescent stains.</p> |

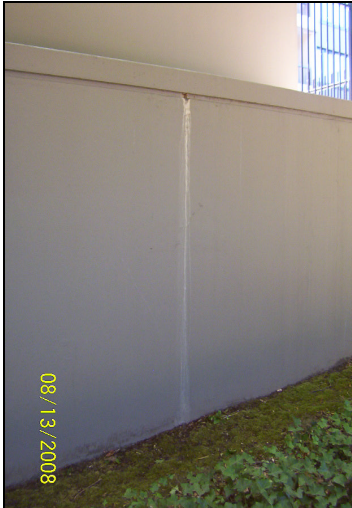
| Harrison West Condominiums-CA-Photos | Exteriors & Sitework-Description |
|---|--|
| | <p>More retaining wall water and efflorescent stains.</p> |

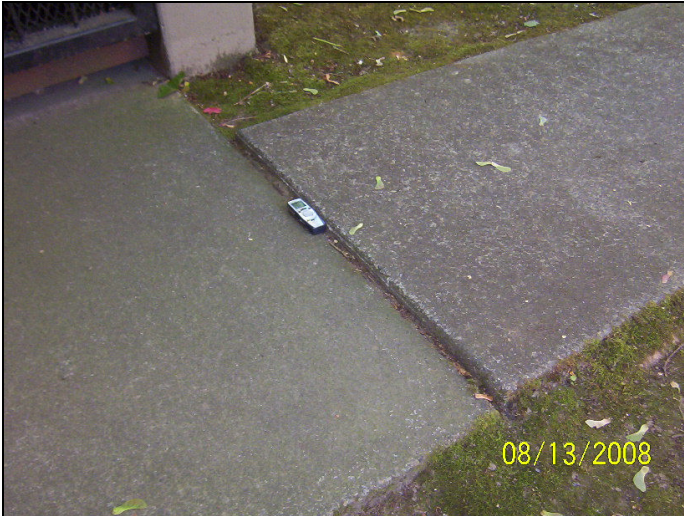
| Harrison West Condominiums-CA-Photos | Exteriors & Sitework-Description |
|---|---|
| | <p>View of settlement between the concrete slab landing and the sidewalk to the northwest exit gate shown in the previous photo; note the author's digital recorder indicating an approximately 1" settlement between slabs, representative of a tripping hazard.</p> |

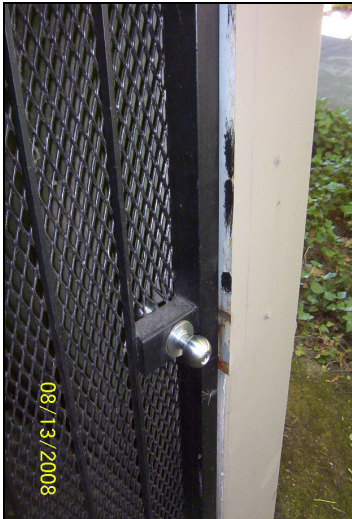
| Harrison West Condominiums-CA-Photos | Exteriors & Sitework-Description |
|---|---|
| | <p>View of the steel jamb at the northwest exit gate shown in the previous photo; the gate is rubbing on the jamb exposing bare metal.</p> |

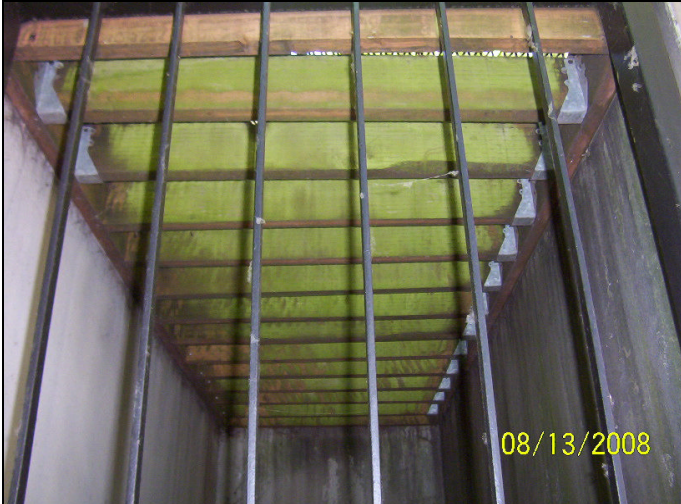
| Harrison West Condominiums-CA-Photos | Exteriors & Sitework-Description |
|---|--|
| <p style="text-align: right; color: yellow;">08/13/2008</p> | <p>View of the 2x6 wood joists supporting a steel grate above the northwest exit gate shown in the previous photo; the joists and ledgers are supporting algae growth but appear to be pressure treated.</p> |

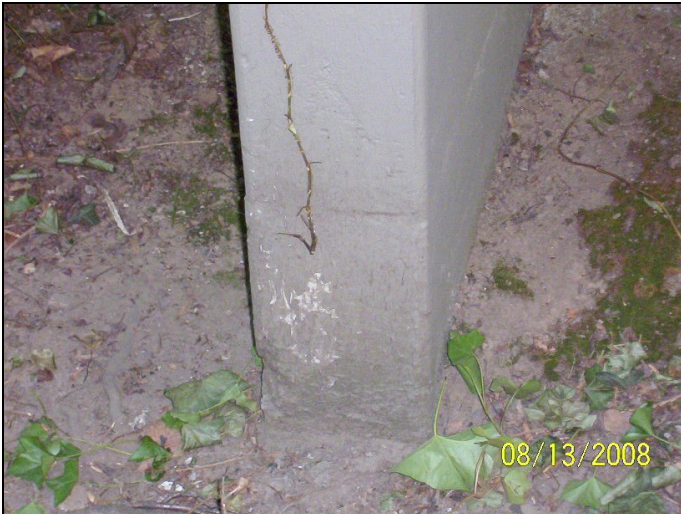
| Harrison West Condominiums-CA-Photos | Exteriors & Sitework-Description |
|---|--|
| <p style="text-align: right; color: yellow;">08/13/2008</p> | <p>View of a concrete stem wall at the north façade of building #2, between units #2 &amp; #3; note the coating is peeling.</p> |

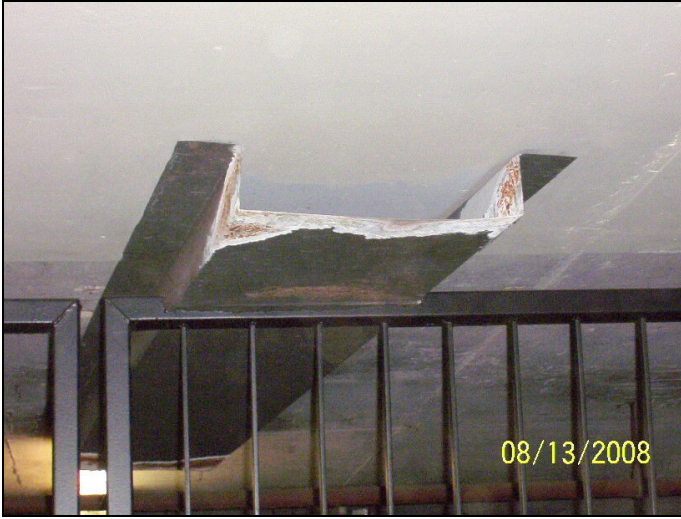
| Harrison West Condominiums-CA-Photos | Exteriors & Sitework-Description |
|---|--|
| <p style="text-align: right; color: yellow;">08/13/2008</p> | <p>View of an exhaust duct surface applied to the parking garage soffit below unit #3, building #2; note the corrosion on the end of the duct.</p> |

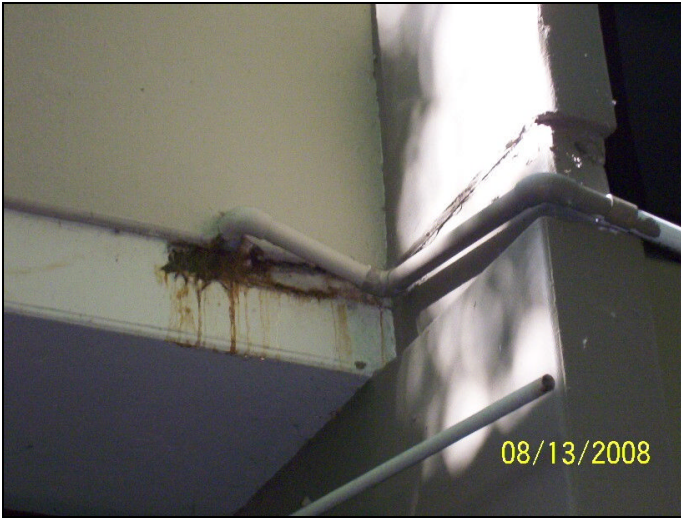
| Harrison West Condominiums-CA-Photos | Exteriors & Sitework-Description |
|---|--|
| <p style="text-align: right; color: yellow;">08/13/2008</p> | <p>View of corrosion above the soffit at a pipe penetration, above the light fixture shown in the previous photo.</p> |

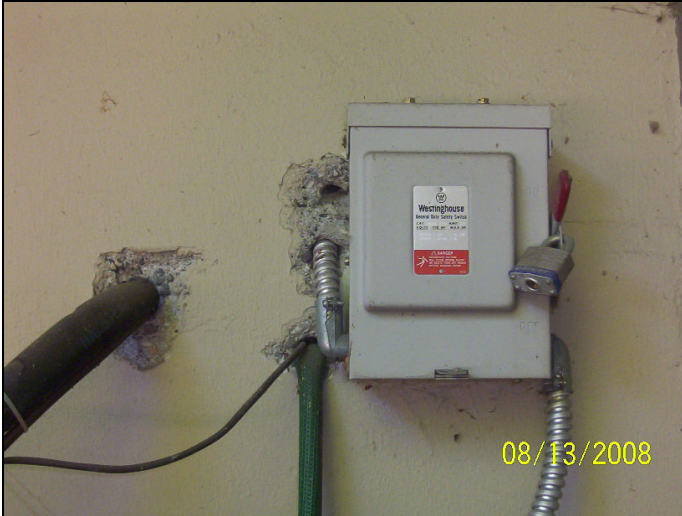
| Harrison West Condominiums-CA-Photos | Exteriors & Sitework-Description |
|---|---|
| | <p>View of the Westinghouse disconnect switch servicing the condenser providing air-conditioning to the maintenance shop; note the wall penetrations have been not been sealed or grouted shut.</p> |

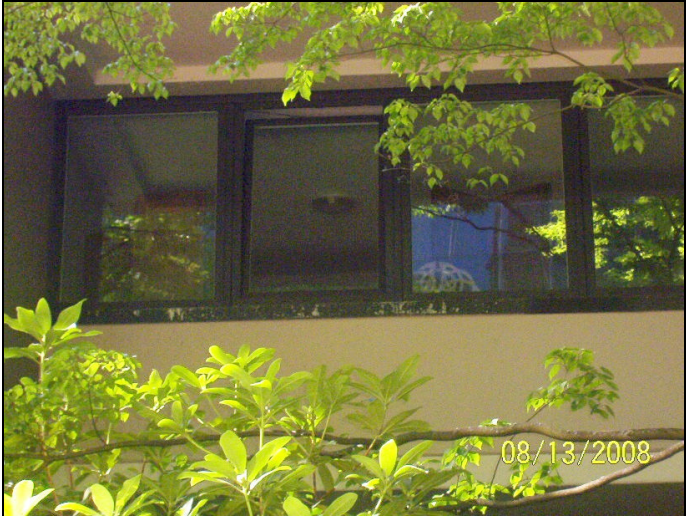
| Harrison West Condominiums-CA-Photos | Exteriors & Sitework-Description |
|---|---|
| <p>08/13/2008</p> | <p>View of the coating peeling on sheet metal flashing below window frames at the east end of unit #6, building #3.</p> |

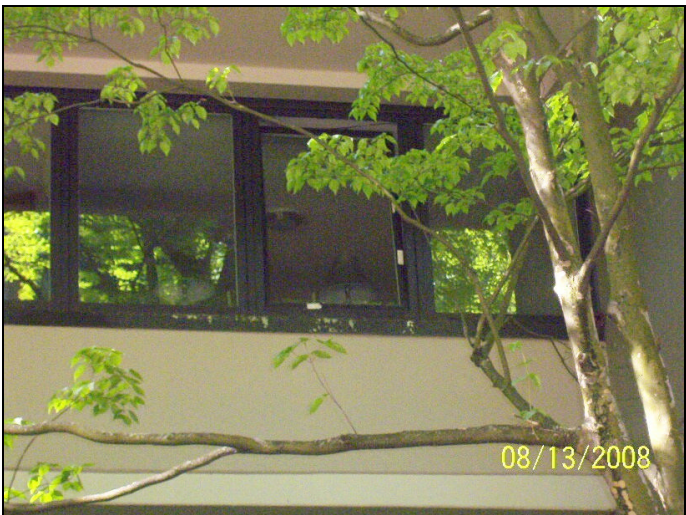
| Harrison West Condominiums-CA-Photos | Exteriors & Sitework-Description |
|---|---|
| <p>08/13/2008</p> | <p>View of the coating peeling on sheet metal flashing below window frames at the west end of unit #6, building #3.</p> |

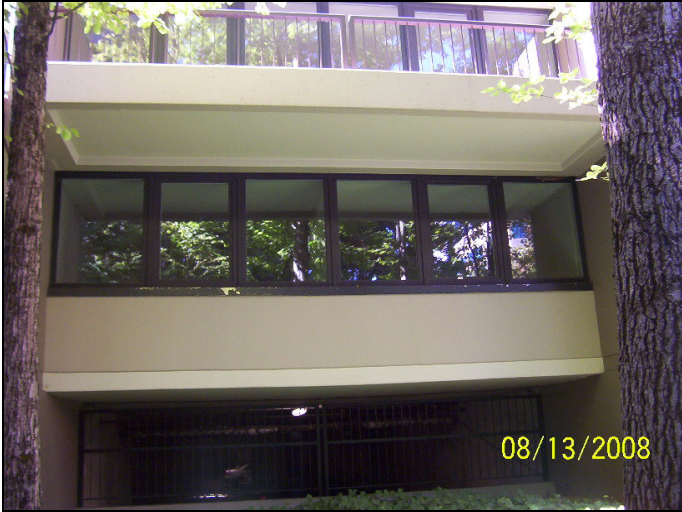
| Harrison West Condominiums-CA-Photos | Exteriors & Sitework-Description |
|---|--|
| <p>08/13/2008</p> | <p>View of the coating peeling on sheet metal flashing below window frames at the west end of building #2, unit #1.</p> |

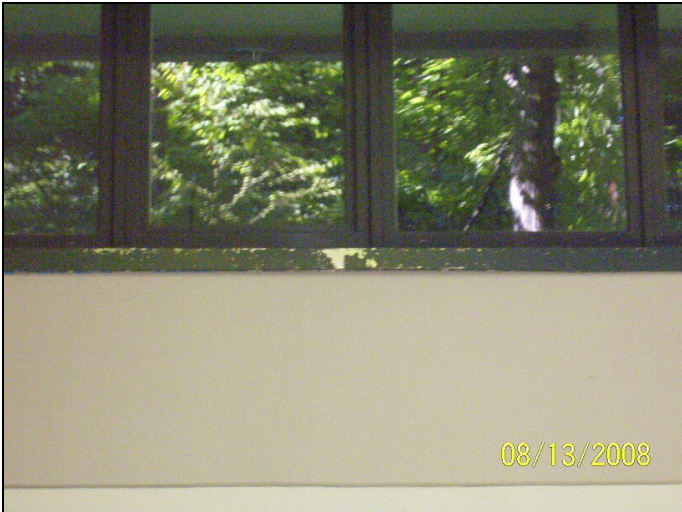
| Harrison West Condominiums-CA-Photos | Exteriors & Sitework-Description |
|---|--|
| <p>08/13/2008</p> | <p>Close-up view of the coating peeling on sheet metal flashing below window frames shown in the previous photo, building #2, unit #1.</p> |

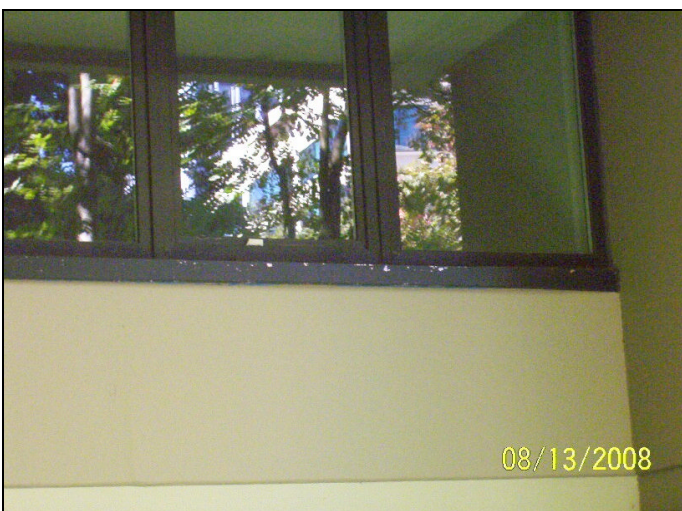
| Harrison West Condominiums-CA-Photos | Exteriors & Sitework-Description |
|---|--|
| <p>08/13/2008</p> | <p>Close-up view of the coating peeling on sheet metal flashing below window frames shown in the previous photo, building #2, unit #1.</p> |

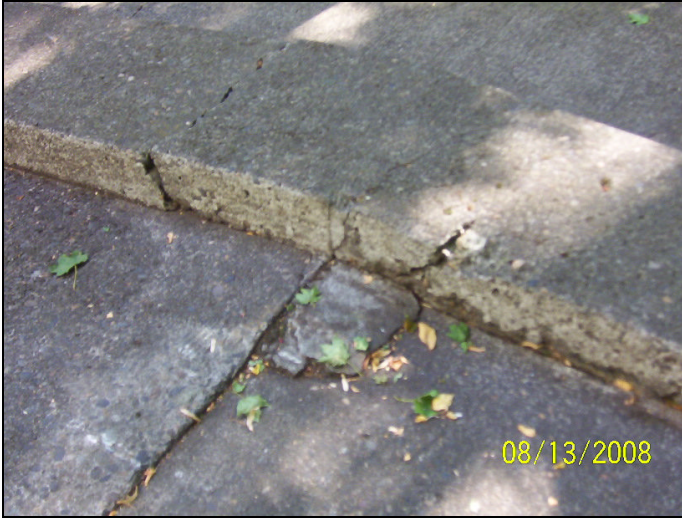
| Harrison West Condominiums-CA-Photos | Exteriors & Sitework-Description |
|---|--|
| <p>08/13/2008</p> | <p>View of cracked concrete driveway and retaining wall sections of the ramp into the parking garage, this on the east side.</p> |

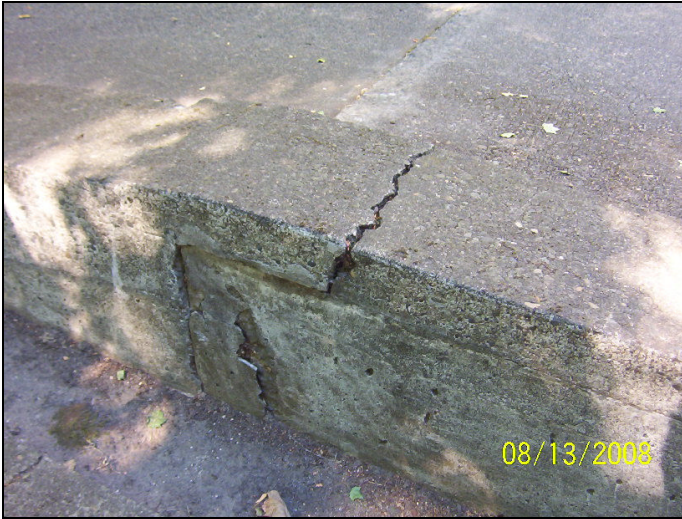
| Harrison West Condominiums-CA-Photos | Exteriors & Sitework-Description |
|---|--|
| <p>08/13/2008</p> | <p>View of cracked concrete retaining wall sections of the ramp into the parking garage, this on the west side.</p> |

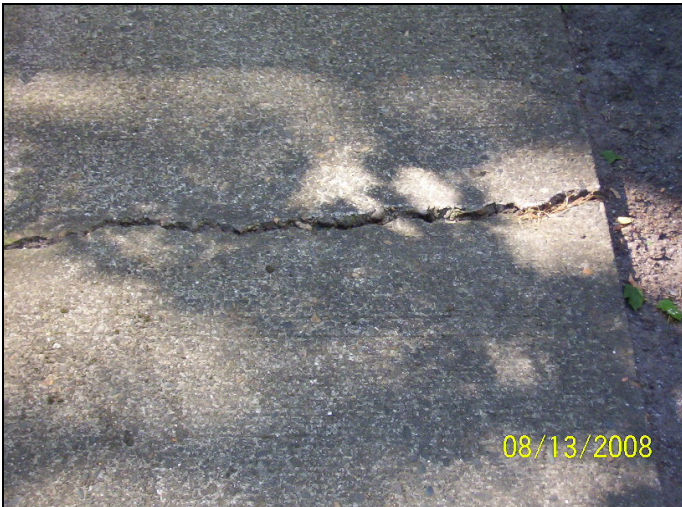
| Harrison West Condominiums-CA-Photos | Exteriors & Sitework-Description |
|---|--|
| <p>08/13/2008</p> | <p>View of the cracked driveway into the parking garage.</p> |

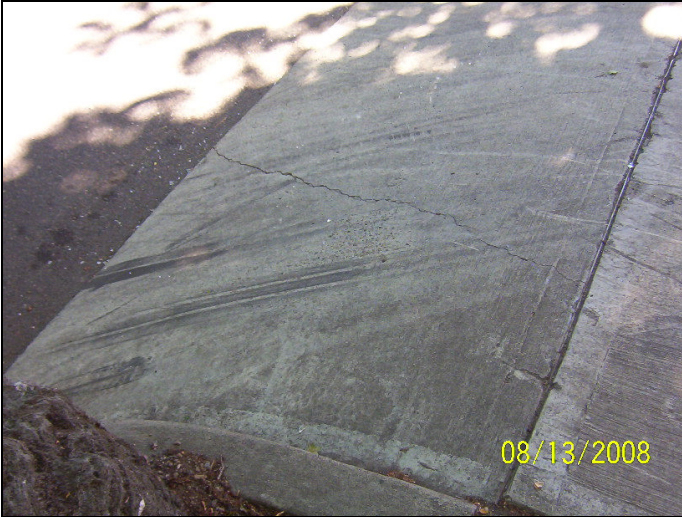
| Harrison West Condominiums-CA-Photos | Exteriors & Sitework-Description |
|---|--|
| | <p>View of a steep section of the curb-cut apron into the porte cochere driveway along SW Harrison Street, at the east side.</p> |

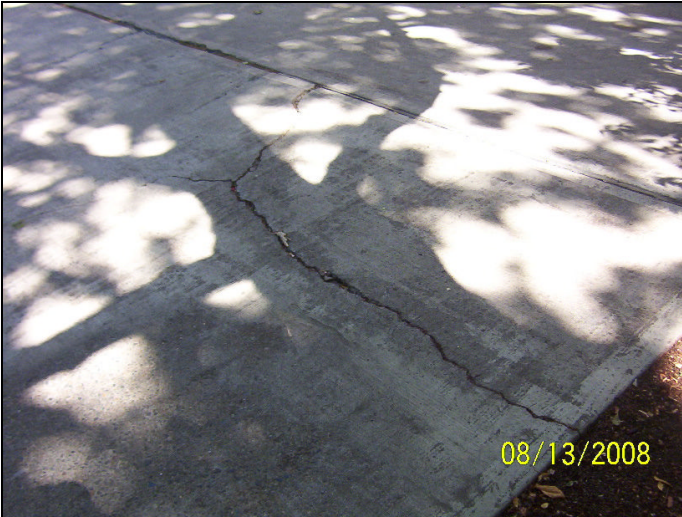
| Harrison West Condominiums-CA-Photos | Exteriors & Sitework-Description |
|---|--|
| | <p>View of cracks in the curb-cut apron into the porte cochere driveway at SW Harrison Street, at the east side.</p> |

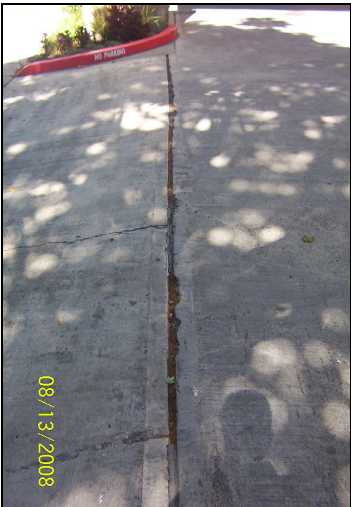
| Harrison West Condominiums-CA-Photos | Exteriors & Sitework-Description |
|---|--|
| | <p>View of the crown into the porte cochere driveway at SW Harrison Street, at the east side. The apron is cracked and the slabs have settled differentially, creating tripping hazards.</p> |

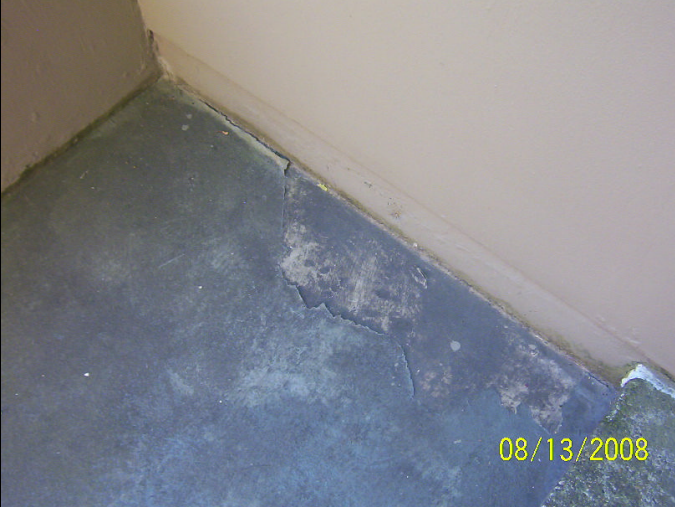
| Harrison West Condominiums-CA-Photos | Exteriors & Sitework-Description |
|---|---|
| <p>08/13/2008</p> | <p>View of the northeast exit staircase from the east plaza, looking at the first landing; note the coating appears to be peeling and delaminating.</p> |

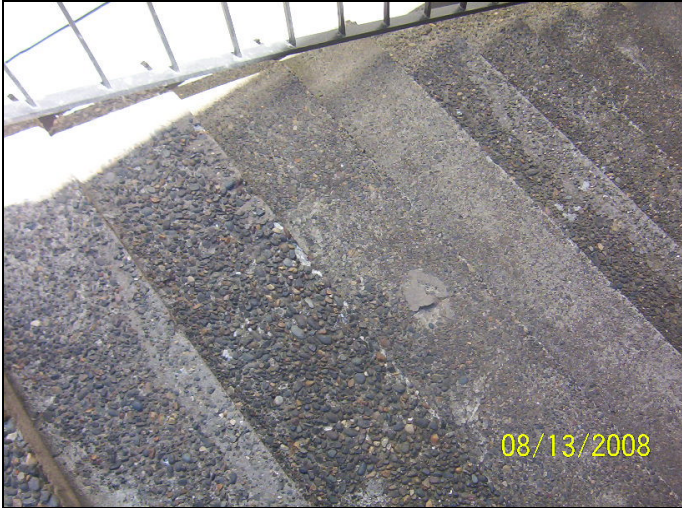
| Harrison West Condominiums-CA-Photos | Exteriors & Sitework-Description |
|---|---|
| | <p>Close-up view of the treads and nosings at the exit staircase from the plaza between buildings #4 &amp; #5; the concrete exposed aggregate is spalling off at tread nosings throughout these staircases.</p> |

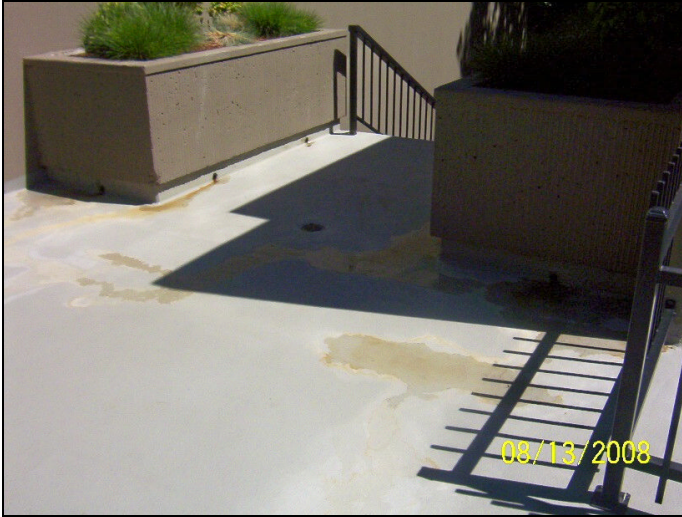
| Harrison West Condominiums-CA-Photos | Exteriors & Sitework-Description |
|---|--|
| | <p>View of the waterproof membrane surface applied to the plaza in 2006; note the dirt stains on the surface created by drains from the planters and the lack of positive drainage to the area drain between planters.</p> |

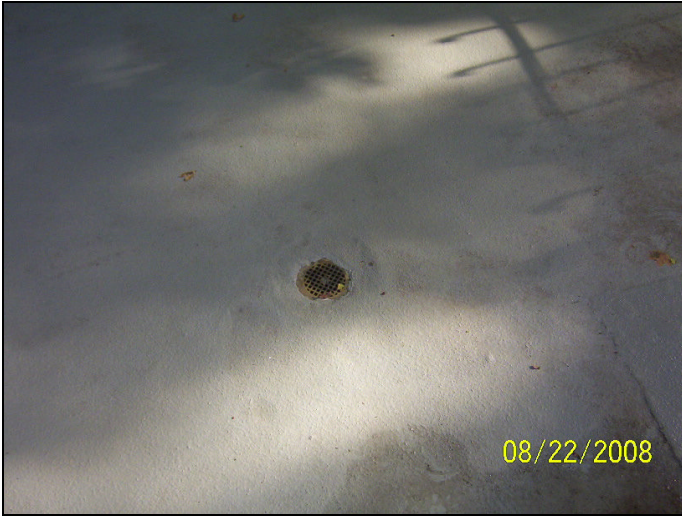
| Harrison West Condominiums-CA-Photos | Exteriors & Sitework-Description |
|---|--|
| | <p>View of the typical area drain in the plaza with the liquid waterproof membrane coating where it appears some drains have been added in areas of concrete creep.</p> |

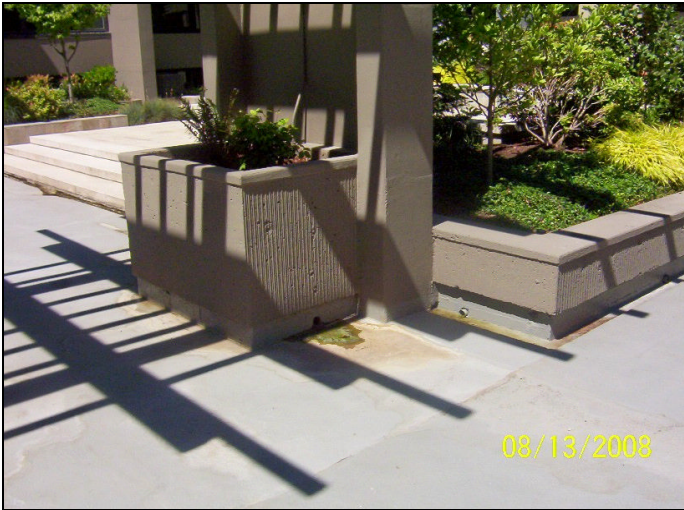
| Harrison West Condominiums-CA-Photos | Exteriors & Sitework-Description |
|---|---|
| | <p>View of the stains on the waterproof surface from the planter box; note the open gutter around the raised planter.</p> |

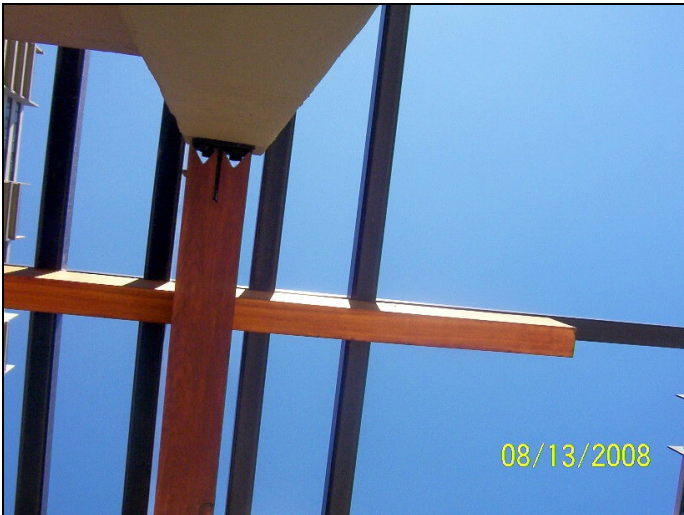
| Harrison West Condominiums-CA-Photos | Exteriors & Sitework-Description |
|---|---|
| | <p>View of the wood trellis connection to the concrete wall, typical at the plaza; note the lack of sheet metal caps on the top of the wood components.</p> |

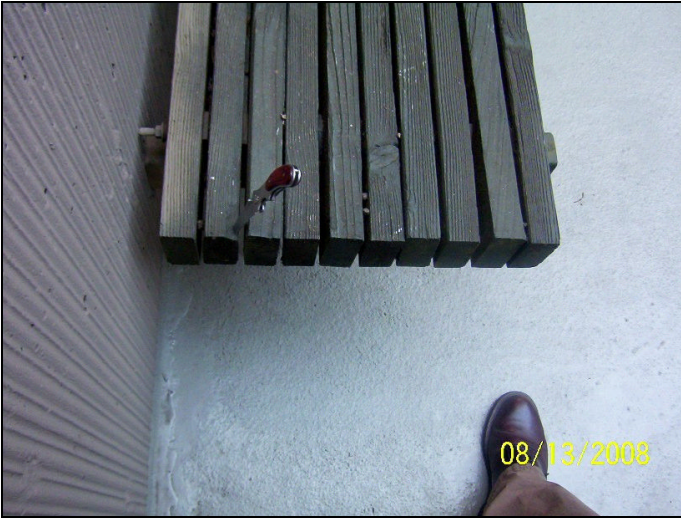
| Harrison West Condominiums-CA-Photos | Exteriors & Sitework-Description |
|---|--|
| | <p>View of the wood bench at the sitting area adjacent to the exit staircase from the north plaza between buildings #1 &amp; #2; note the author's knife blade easily inserted into the 2x4s indicating the presence of rot.</p> |

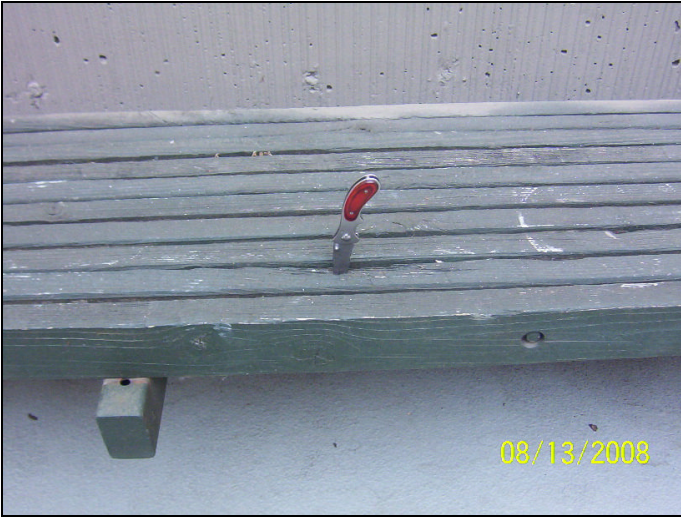
| Harrison West Condominiums-CA-Photos | Exteriors & Sitework-Description |
|---|--|
| | <p>Another view of the wood bench shown in the photo above; the author's knife blade was also easily inserted into the 2x4s at this location indicating the presence of rot.</p> |
