| Harrison West Condominiums-CA-Photos | Roof & Elevator Equip-Description |

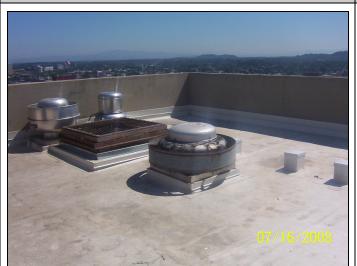
Another general view of the Firestone single-ply TPO roof membrane installation at the elevator penthouse, looking northeast. The fan-hood in the foreground is an inactive elevator penthouse exhaust fan; the room is now air-conditioned. The square fan-hood ventilates the fireman's staircase; at the rear and left side of the photo, is the trash chute exhaust fan and right of it is the electrical closet exhaust fan.

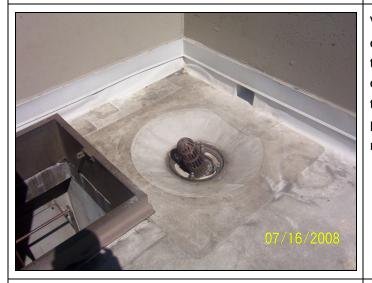
View of the roof drain in the northwest corner of the elevator penthouse roof; note the strainer cap is tilted and should be corrected. Also note the parapet scupper to the right of the drain and the several patches on the single ply roofing membrane.
