Harrison West Condominiums-CA-Photos	Units-Description

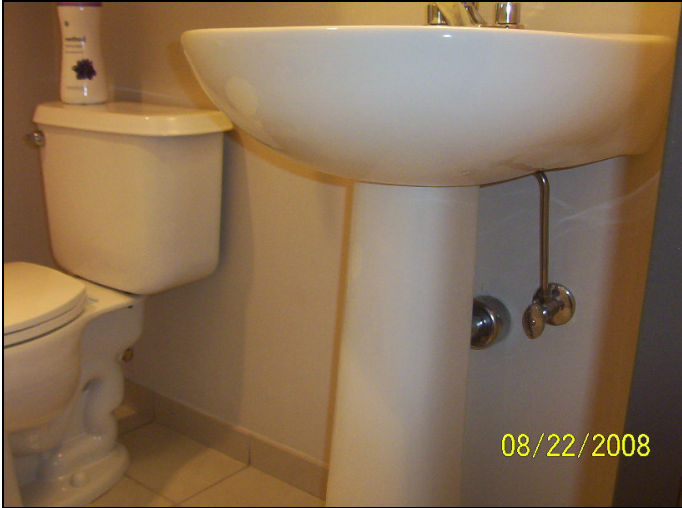
<p>View of the bathroom lavatory plumbing; supply lines from the wall to the fixtures are chromium plated metal.</p>

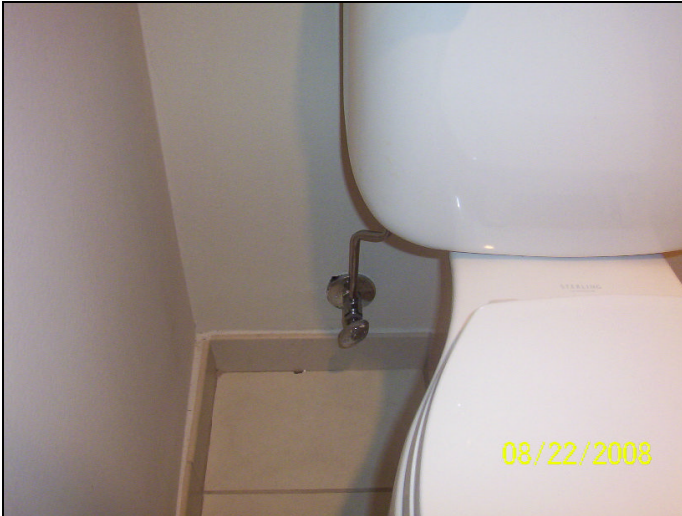
<p>View of the bathroom water closet plumbing; supply lines from the wall to the fixtures are chromium plated metal.</p>

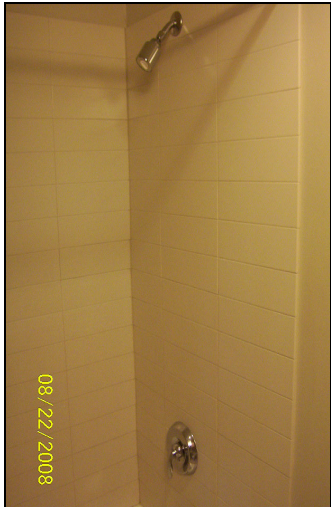
<p>View of the bathroom tub/shower enclosure plumbing; supply lines from the wall to the fixtures are chromium plated metal.</p>

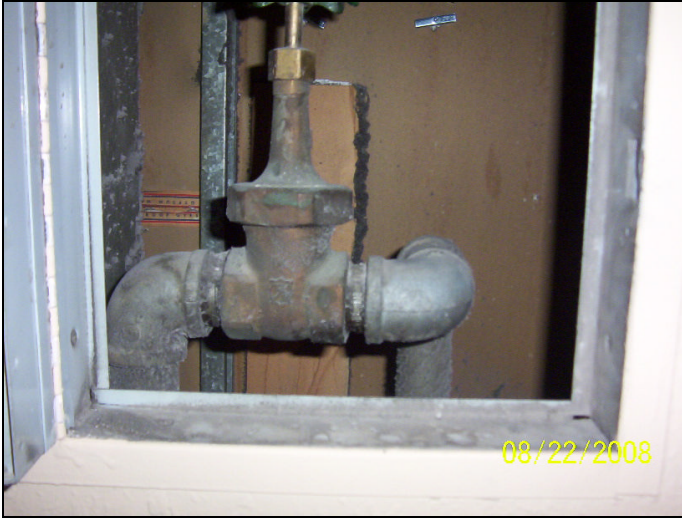
<p>View of the galvanized iron supply piping within the walls, viewed from a Milcor access door in the common area hallway. Valves are in good to fair condition, according to management and are replaced as needed.</p>

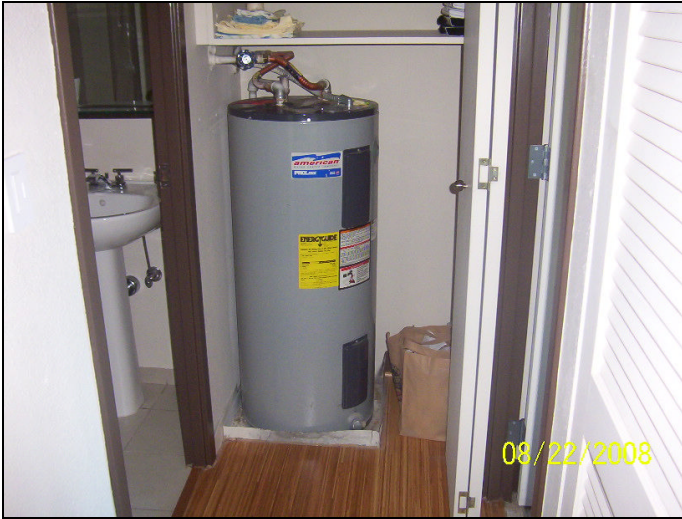
<p>View of the typical electric water heater present in each unit.</p>

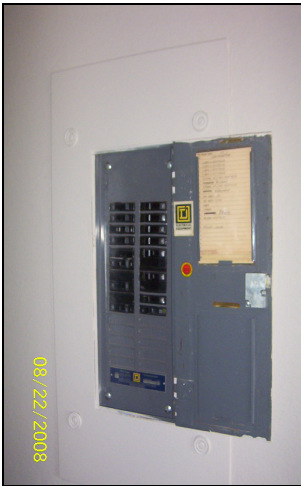
<p>View of the typical electric sub-panel present in each unit; each unit sub-panel is rated at 225 amp, 120/240 volt, 1Φ, 3-wire, according to management, but disconnect switches at meters indicate that unit service is limited to 150 amp.</p>

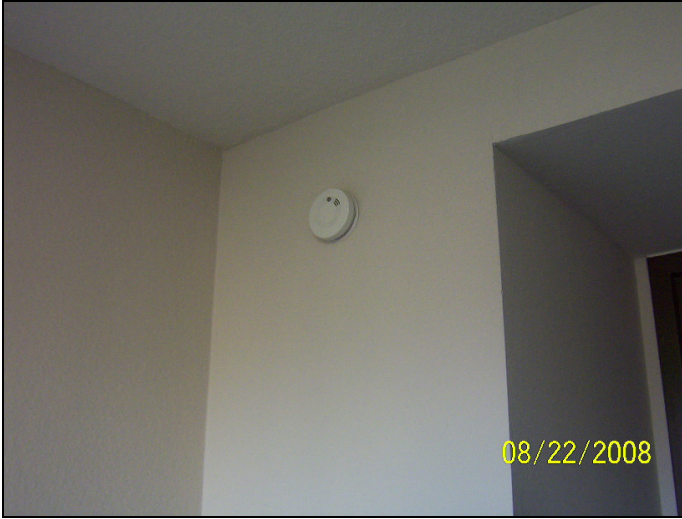
<p>View of a typical ionization detector installed in the units.</p>

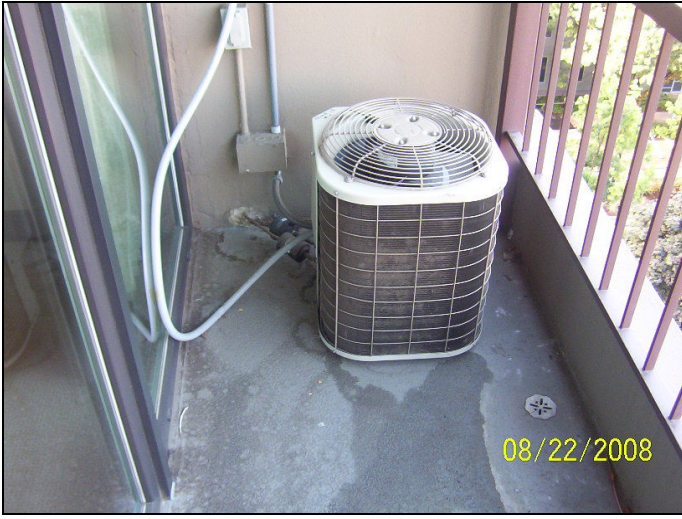
<p>View of the typical air-conditioning condenser installed at each deck; owners were given the option of upgrading their heating system. This appears to be one of the older condensers. Also, note the deck floor drain that appears to be above the drainage pattern on this deck; decks were coated with a liquid waterproof membrane with integral grit in 2006, according to management.</p>

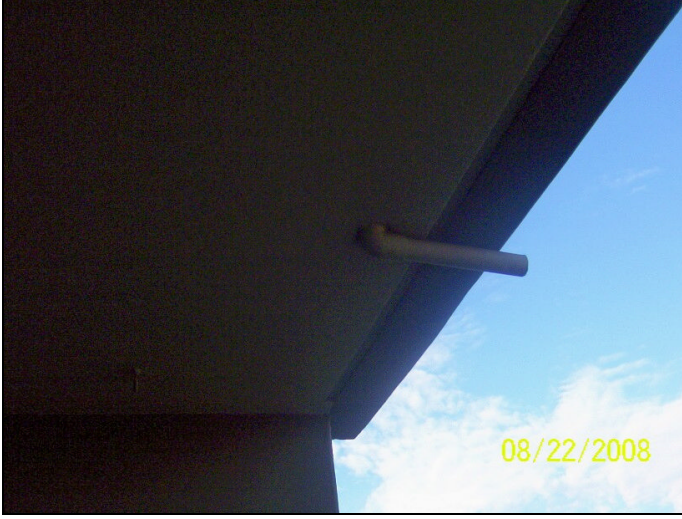
<p>View of the deck drain outflow to daylight from the unit above, typical throughout the tower building.</p>

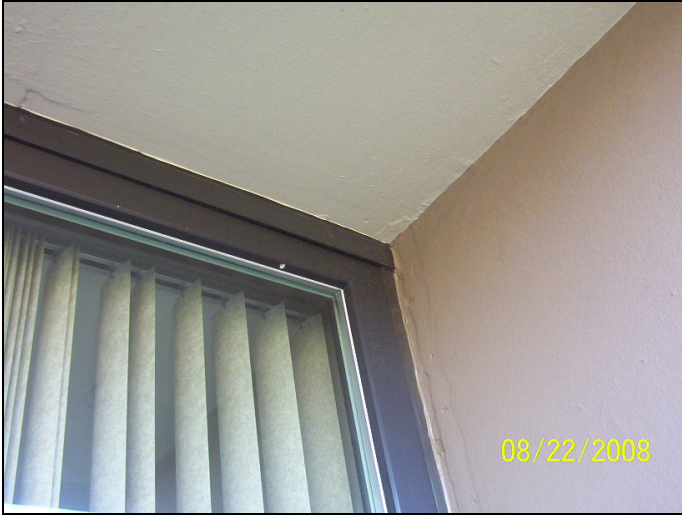
<p style="text-align: right; color: yellow;">08/22/2008</p>	<p>View of the head and jamb of the typical metal window frame, typical at floors #2 through #26, at the tower building; the metal frame has been caulked at the jambs and the head is covered by a metal flashing that appears to be caulked at the top edge.</p>

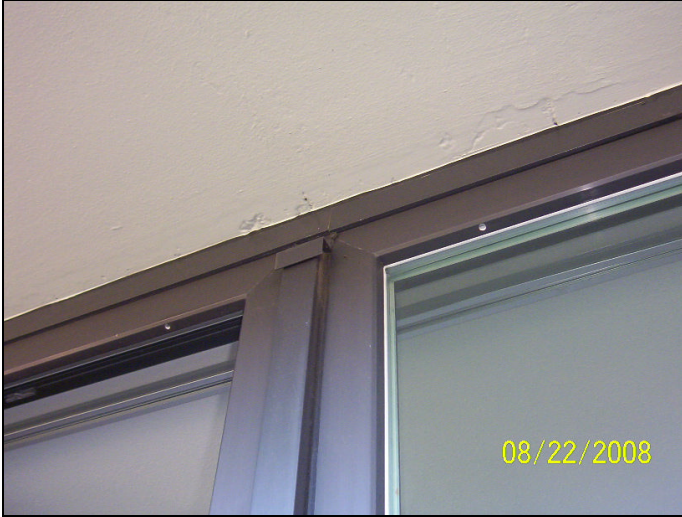
<p style="text-align: right; color: yellow;">08/22/2008</p>	<p>View of the head and jamb of the typical metal window frame at the movable section, typical at floors #2 through #26, at the tower building; the head is covered by a metal flashing and appears to be caulked at the top edge. The movable section functions as an awning window or as a casement door, operable by a single handle.</p>

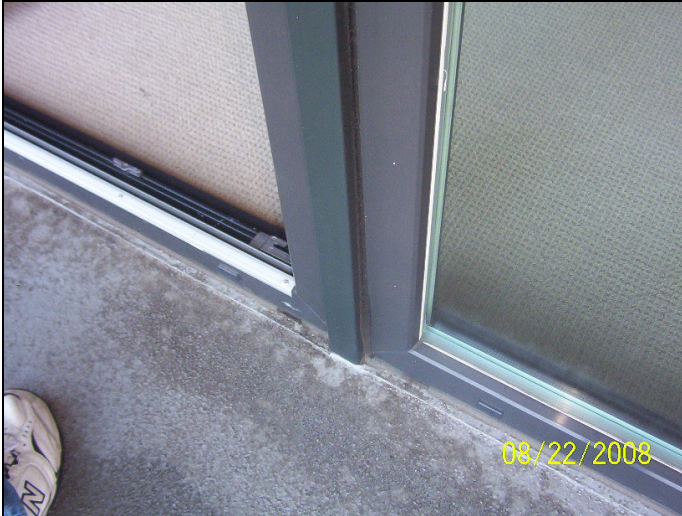
<p style="text-align: right; color: yellow;">08/22/2008</p>	<p>View of the sill and jamb of the typical metal window frame at the movable section, typical at floors #2 through #26, at the tower building; the sill of the frame appears to be raised approximately ½"-1" above the deck, is caulked, and has weep holes for frame drainage. The occupant indicated no leaks have occurred. The movable section functions as an awning window or as a casement door, operable by a single handle.</p>

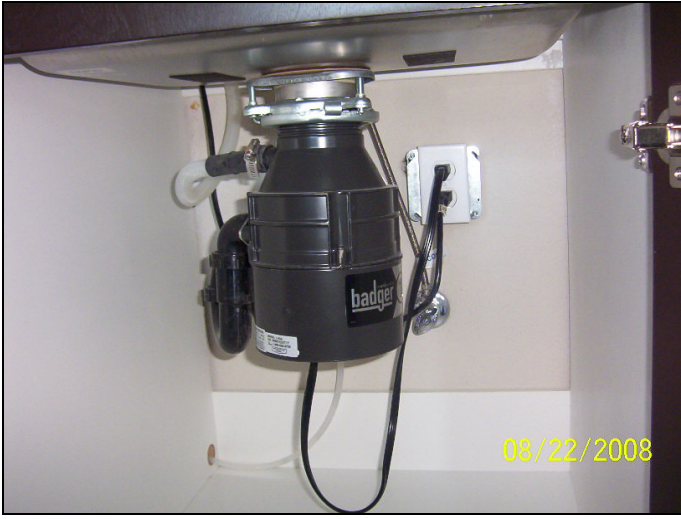
<p style="text-align: right; color: yellow;">08/22/2008</p>	<p>View of the under counter kitchen plumbing in unit #26-B; waste lines are ABS and supply lines are galvanized iron within walls and a combination of stainless steel wire mesh rubber tubing and translucent PEX within cabinets and chromium plated metal where exposed.</p>

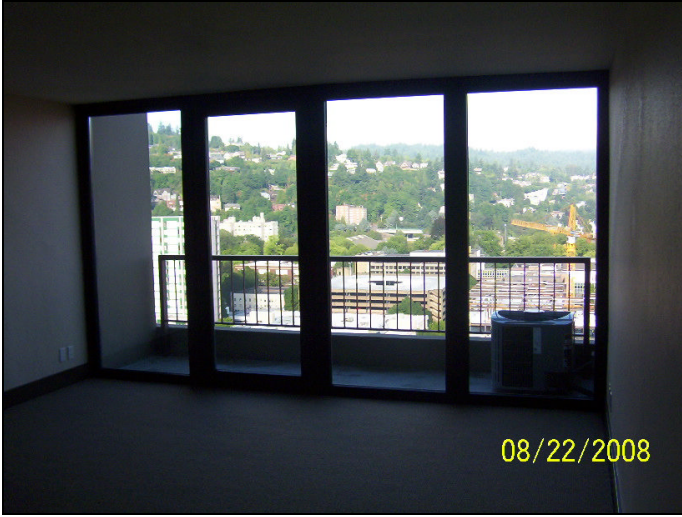
<p>View of master bedroom window wall in unit #26-B; note the second compressor in this unit. This three-bedroom penthouse has two separate furnace and air-conditioning systems.</p>

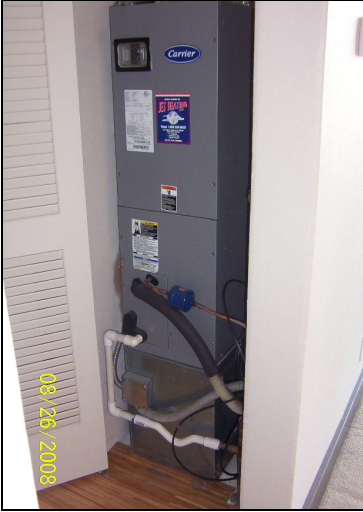
<p>View of a new electric forced-air furnace by Carrier, typical of upgraded systems installed at the owner's option.</p>

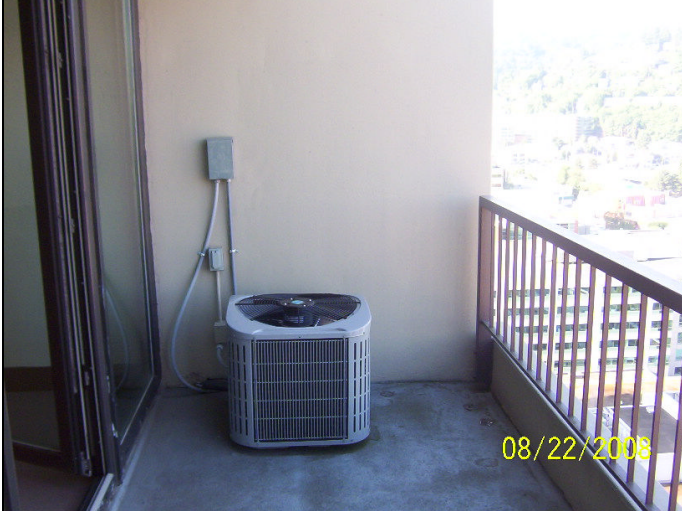
<p>View of a new electric condenser by Carrier, typical of upgraded systems installed at the owner's option.</p>

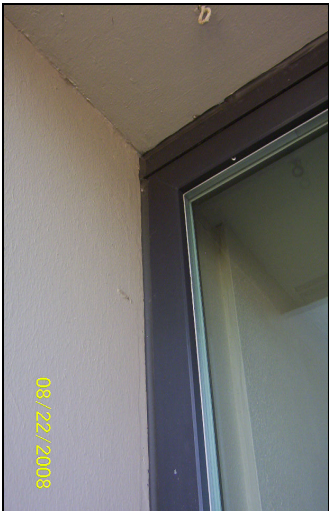
<p>Another view of the head and jamb of the typical metal window frame, typical at floors #2 through #26, at the tower building; the metal frame has been caulked at the jambs and the head is covered by a metal flashing caulked at the top edge.</p>

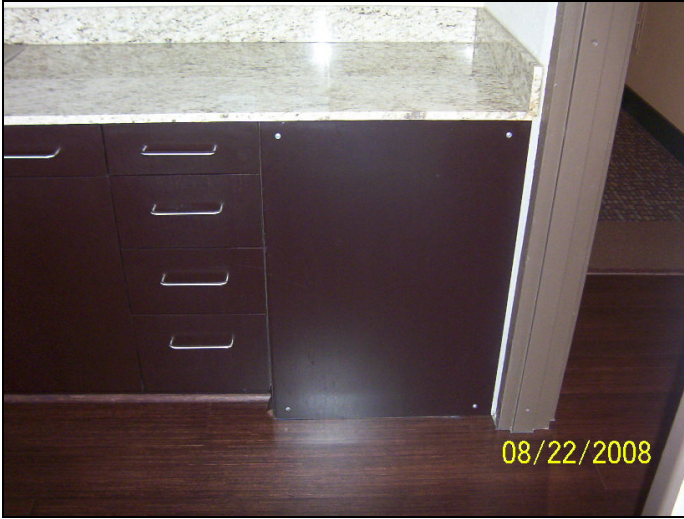
<p style="text-align: right; color: yellow;">08/22/2008</p>	<p>View of an access panel in the kitchen housing a second electrical water heater in the typical 3-bedroom unit in the tower building.</p>

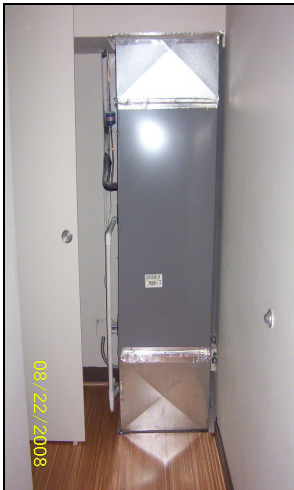
<p style="text-align: right; color: yellow; transform: rotate(-90deg);">08/22/2008</p>	<p>View of the typical electrical forced-air furnace installed in the townhouse units.</p>

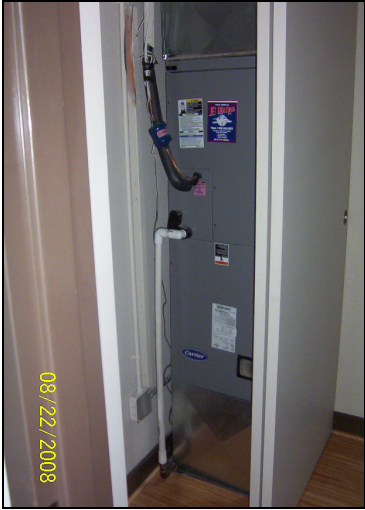
<p>Another forced-air electric furnace in the townhouse buildings.</p>

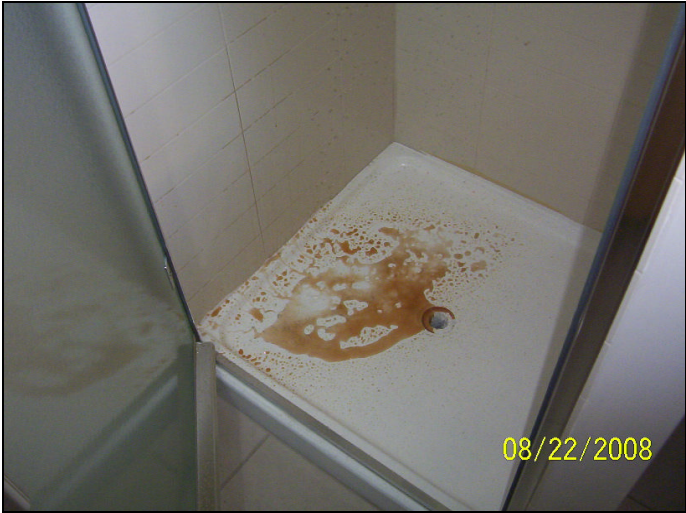
<p>View of rust water in a typical shower stall inside one of the townhouse buildings; the rust is probably due to the galvanized water supply piping that is original.</p>
