LEVEL 1
RESERVE STUDY
FOR
HARRISON WEST CONDOMINIUMS
OWNERS ASSOCIATION
(Current Assessment Funding Model)

January 1, 2009 - December 31, 2009

Harrison West Condominiums

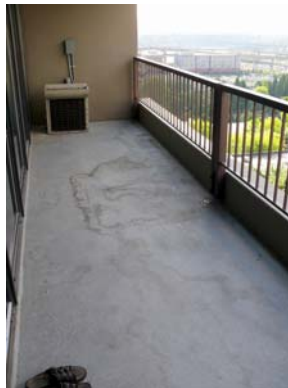
Funding for the periodic application of Lympall Iso/Flex elastomeric membrane to all unit balconies.

Condition: Good

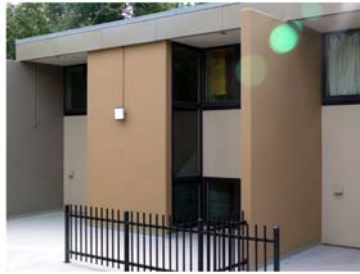
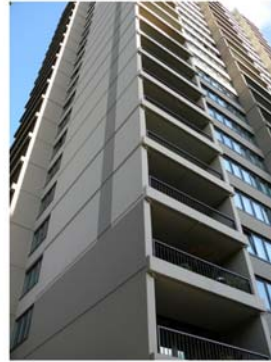
Exterior Paint - Concrete & Plaster Surfaces continued...

Funding for the periodic repainting of all exterior walls and other concrete surfaces. This painting expense is not scheduled to be included in the ongoing maintenance painting cycle. Due to the magnitude of this task and the expenses associated with painting the upper sections of building 1, this work should be scheduled for completion at the same time.

The paint material is an elastomeric coating manufactured by Sherwin-Williams Paint Company.

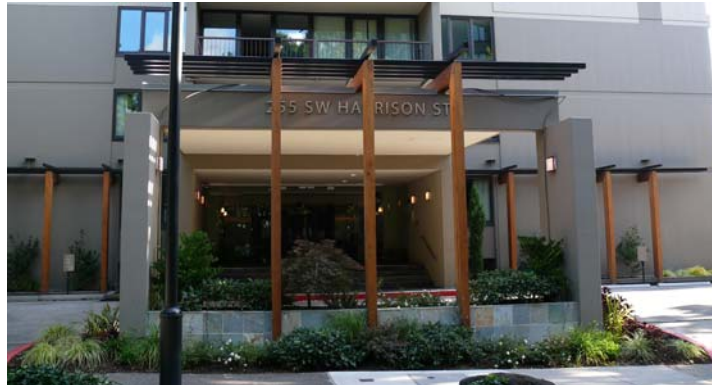
Exterior Paint - Decorative Landscape Trellises continued...

Funding for the periodic repainting and sealing of the decorative landscape trellises. All of the trellises are scheduled to be painted at the same time.

Condition: Fair to Good

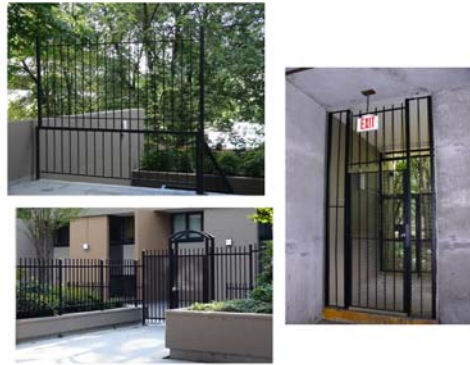
Exterior Paint - Railings / Fencing / Grilles continued...

Funding for the periodic repainting of the painted metal fencing and security grilles. This expense is equally allocated over the eight year lifecycle of the component and is included in the ongoing maintenance painting schedule. Funding for this expense will be available beginning in 2009.

Condition: Fair to Good

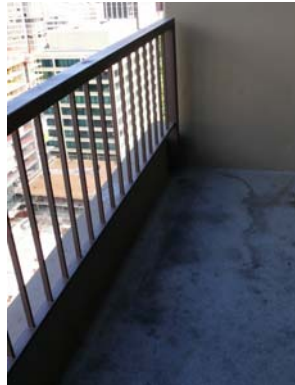
Exterior Paint - Unit Balcony Railings continued...

Funding for the periodic repainting of the unit balcony railings. This expense is scheduled to occur at the same time the exterior of building 1 is painted.

Condition: Good

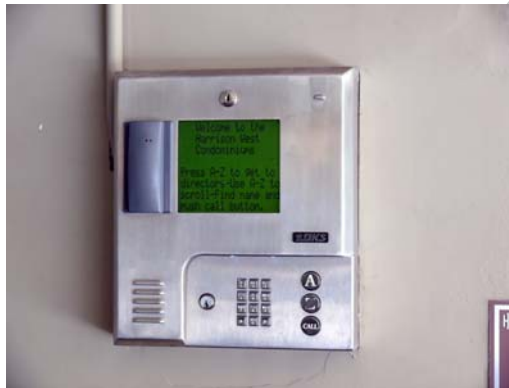
Funding contingency for repair and replacement of electronic entry system components in building 1.

Condition: Good

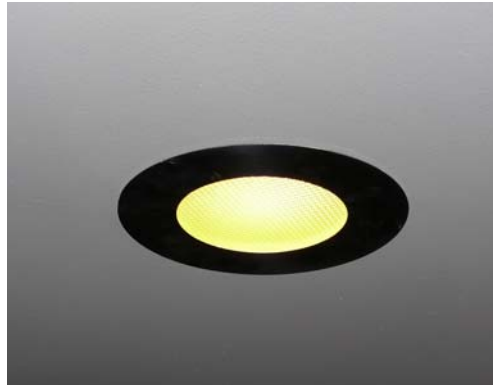
Lighting - Interior Recessed Fixtures - Replacement continued...

Funding allowance for the replacement of interior recessed light fixtures in building 1.

Condition: Good

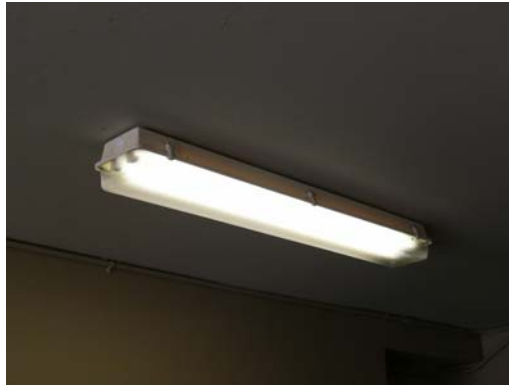
Lighting - Interior Utility Fixtures - Replacement continued...

Funding allowance for the replacement of interior utility light fixture located in the parking garage, utility areas and stairwells.

Condition: Good

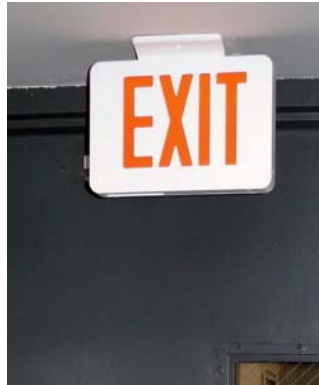
Lighting - Low Voltage Exit Signs - Replacement continued...

Funding allowance for the replacement of low voltage lighted exit signs in buildings 1.

Condition: Good

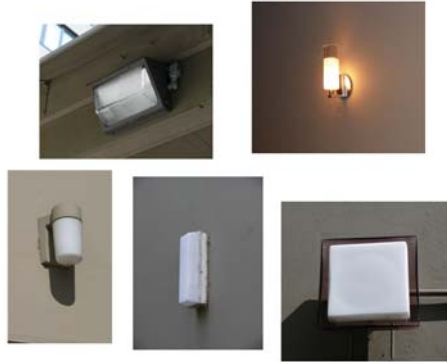
Lighting - Wall Mounted Fixtures - Replacement continued...

Funding allowance for the replacement of interior wall mounted light fixtures in building 1.

Condition: Good

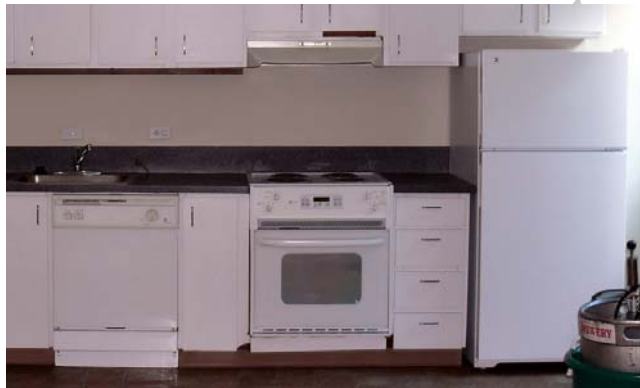
Replacement funding for kitchen appliances located in the association meeting room. Items included in replacement cost estimate; refrigerator, dishwasher, electric range, garbage disposal.

Condition: Good

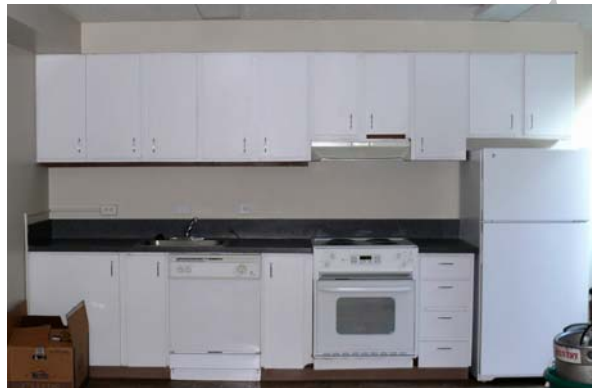
Replacement funding for kitchen cabinets and countertops located in the association meeting room.

Condition: Good

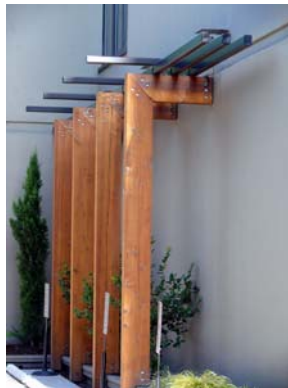
Funding contingency for replacement of the wooden portion of the decorative landscape trellises at various locations throughout the property.

Condition: Good

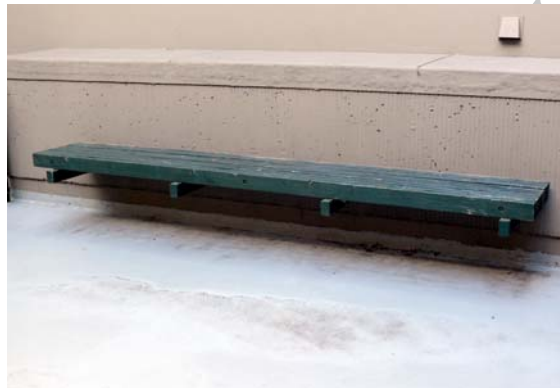
Funding for the replacement of wooden benches located in common areas.

Condition: Fair

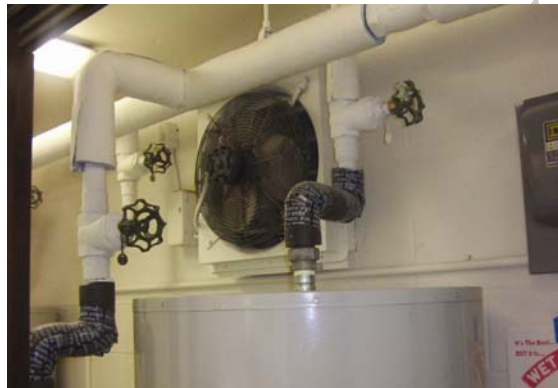
Replacement funding for the laundry room exhaust fan. Maintenance personnel indicate the existing fan is non-functioning. Replacement is scheduled for 2009.

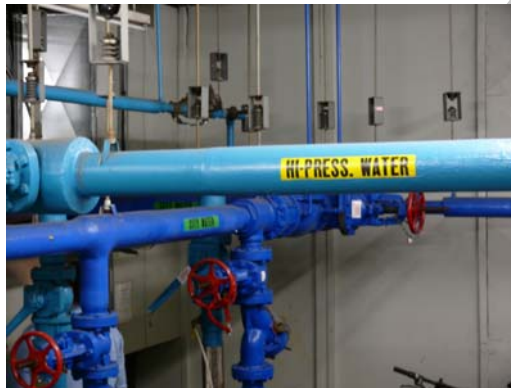
Replacement funding for the water supply control valves used to regulate water supplies for domestic water and fire suppression systems. The valves are scheduled for replacement in 2009.

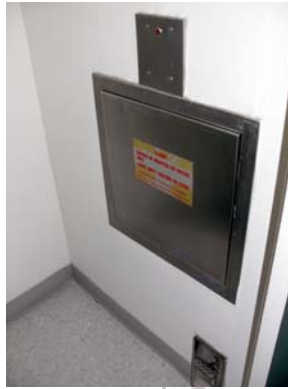
Funding for replacement of the fire-rated trash chute doors at each floor level of building 1. Based on the recommendations of Pielow Fair Associates, LLC in the assessment summary dated May 27, 2005.
