Common Areas-Description

Harrison West Condominiums-CA-Photos Common Areas-Description View of a leak in the hydraulic line behind the pump at the freight elevator; all such leaks should be investigated and corrected. View of the freight elevator hydraulic pump located in a room adjacent to the parking garage in the tower building. View of the freight elevator hydraulic pump jack located in the pit adjacent to the parking garage in the tower building.

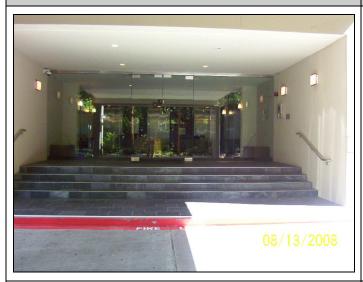
View of the main entrance to the lobby at the tower, building #1.

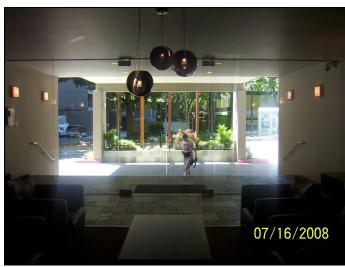
Opposite view of the common area lobby entry doors servicing the elevators that provide access to the residential units at the tower building.

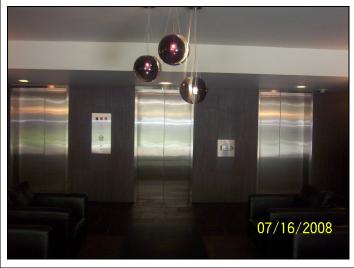
View of the common area lobby servicing the elevators that provide access to the residential units at the tower building.

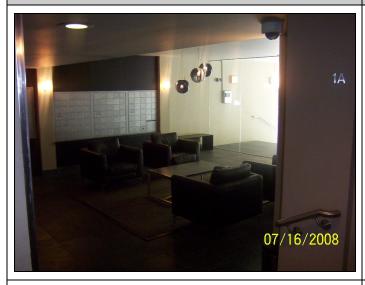
Diagonal view across the common area lobby servicing the elevators that provide access to the residential units at the tower building.

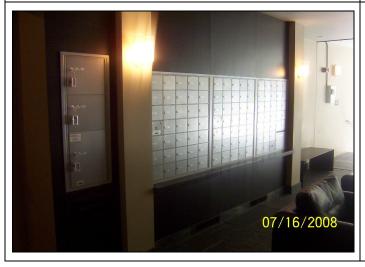
Another view of the mailboxes located in the east common area lobby servicing the elevators that provide access to the residential units at the tower building; note the large parcel boxes to the left side of the photo.

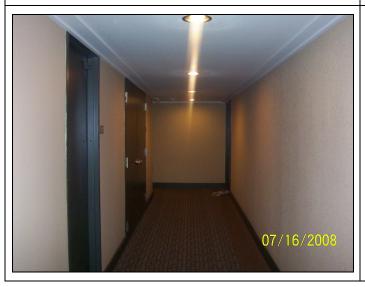
View of the typical common area hallway servicing the residential units at each floor of the tower building. Lighting includes both recessed fluorescent lamps and halogen lamp sidewall sconce fixtures (seen in the photo below).

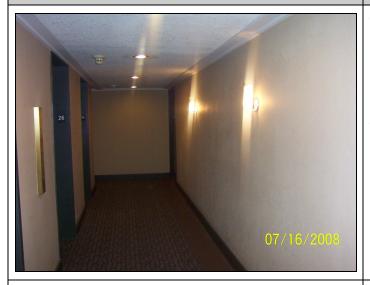
View of another typical common area hallway at the elevator lobby servicing the residential units at each floor of the tower building. The wall mounted lights are halogen lamps that burn 24-hours per day; the ceiling mounted recessed spots are fluorescent lamps.

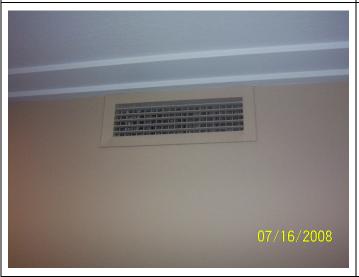
View of the typical supply-air grille at the common area hallways at the Subject Property tower building that pulls fresh air from the fan room located at level #B-1. This grille also provides supply-air under the doors by the crack-method to the residential units.

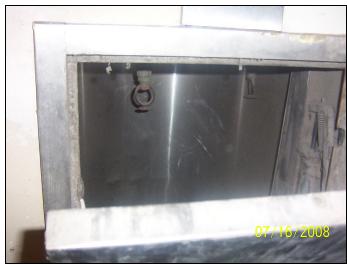
View of the fire sprinkler head installed at the top of the trash chute.

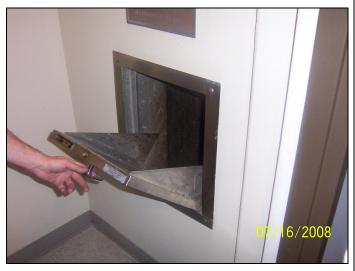
View of another typical trash chute.

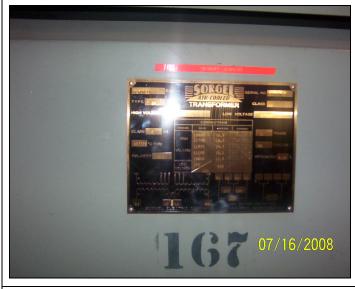
Close-up view of an original Sorgel air-cooled step-down transformer located in a typical common area hallway closet, every third floor.

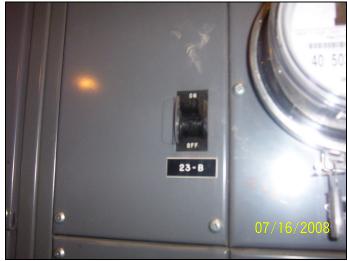
View of the typical unit, electrical panel disconnect switch installation at the Subject Property tower building; the switch indicates a maximum of 150 amps available to each unit.

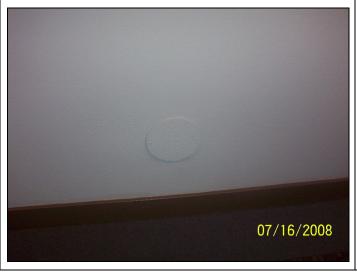
View of a typical plumbing sanitary sewer cleanout access cover plate located in the common area hallways at the Subject Property tower building; there is a single soil stack that all units are connected to, according to management.

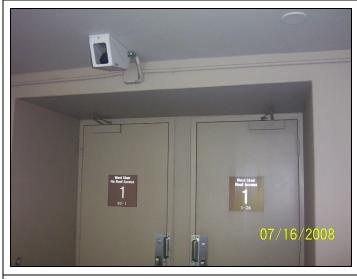
View of the west entry doors to two staircases, the left one to the common areas hallways servicing levels #1 – #B2, without roof access, the right one servicing levels #1 – #26, with access to the roof; note the CCTV camera above the doors.

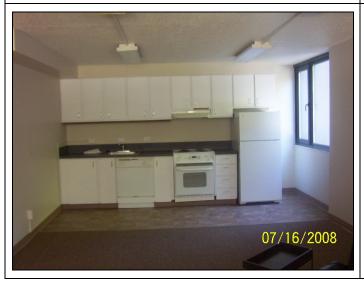
View of the kitchen in the unused unit located at the northeast corner of the first floor. This unit is now used as a conference/meeting room for the HOA.

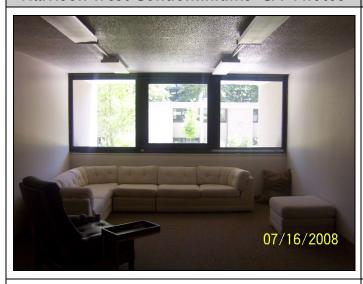
Opposite view of the previous photo showing the living room.

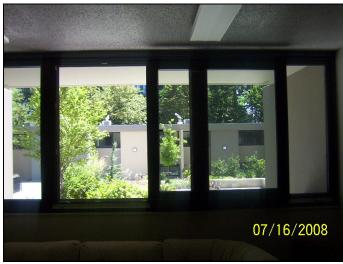
Close-up view of the combination sliding/casement metal frame window, typical at the 1st floor units only at the Subject Property tower building.

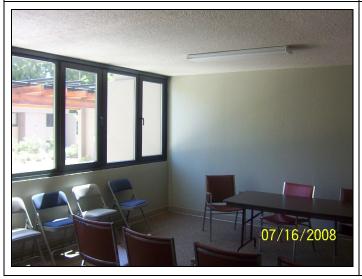
View of the unused unit bedroom located at the northeast corner of the first floor; this area is used as a conference/meeting room.

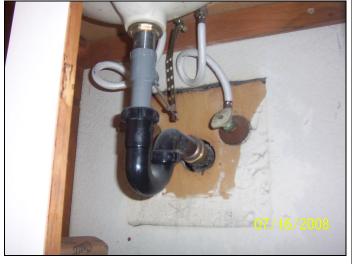
View of the typical lavatory plumbing in the bathroom at the conference/meeting room.

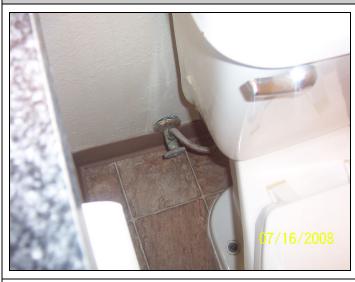
View of the typical water closet plumbing in the bathroom at the conference/meeting room.

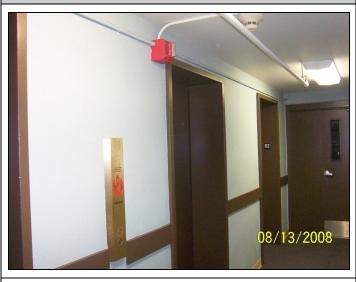
View of the elevator lobby at level #B-2; note the ionization detector, the audio/strobe alarm and the elevator call buttons.

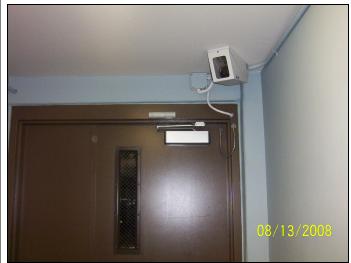
View of a typical CCTV camera at secure entry doors.

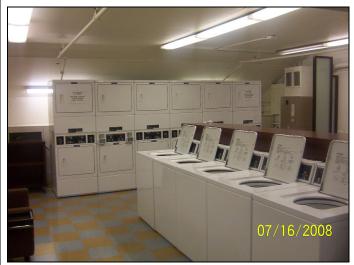
View of the laundry room at level #B in the tower building at the Subject Property.

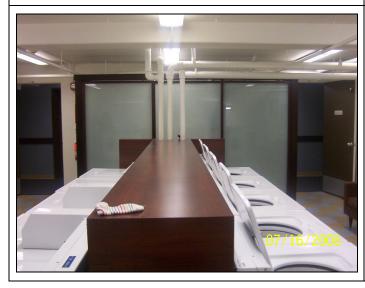
Another view of the laundry room at level #B in the tower building at the Subject Property.

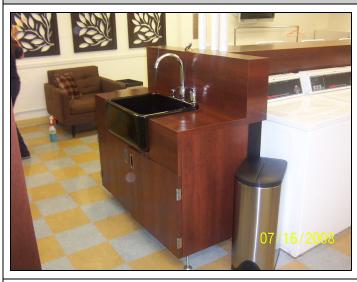
View of the laundry tray/sink at level #B in the tower building at the Subject Property.

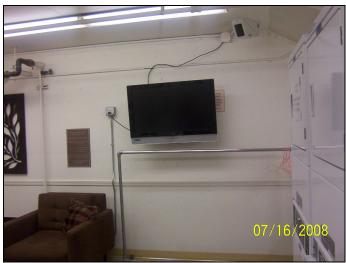
View of the flat screen TV in the laundry room at level #B-1 in the tower building at the Subject Property.

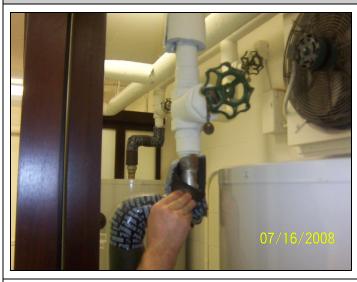
Close-up view of the water supply piping at the electrical water heaters in the laundry room at level #B-1 in the tower building at the Subject Property.

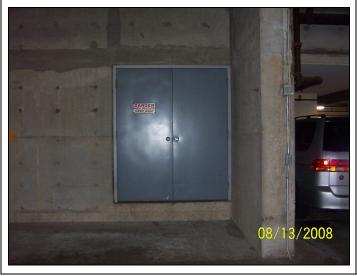
View of the locked transformer vault in the parking garage.

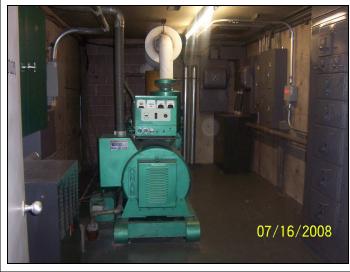
View of the diesel-fired emergency generator located adjacent to the parking garage in level #B-1, in the tower building at the Subject Property.

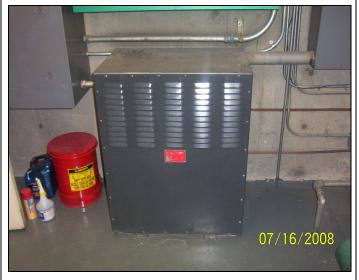
Close-up view of the step-down transformer seen in the previous photo.

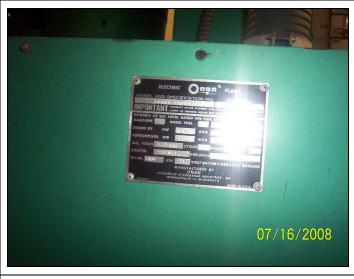
View of the label on the emergency generator power transfer switch by Onan.

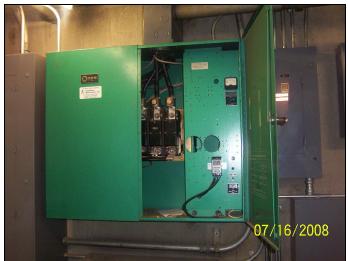
View of the inside of the emergency generator power transfer switch.

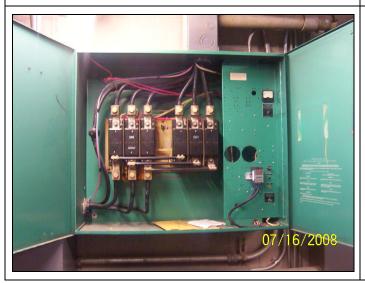
Close-up view of the switches in the emergency generator power transfer switch cabinet.

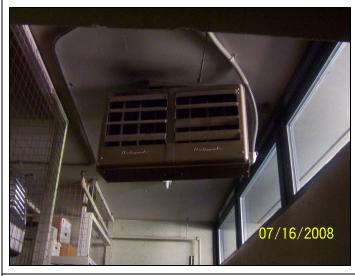
View of a suspended 10 KW electrical space heater by Electromode, located in the common area hallway adjacent to the owner storage lockers area, located in level #B-1; there are two such heaters in this area.

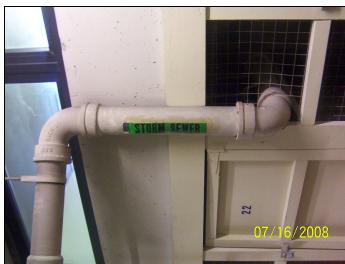
View of a storm sewer line in the owner storage lockers hallway, located in level #B-1.

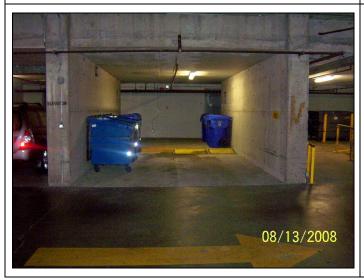
View of the recycling area located in the parking garage.

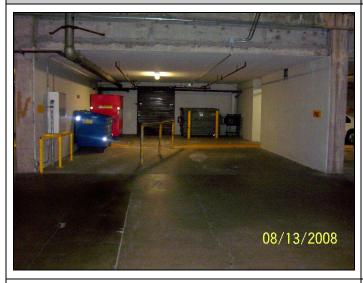
View of the trash compactor overhead door loading area located in the parking garage.

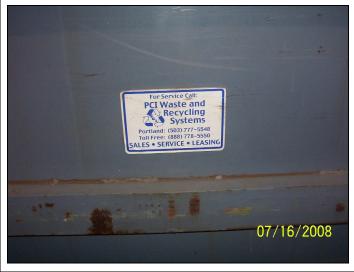
Vendor information on the refuse compactor.

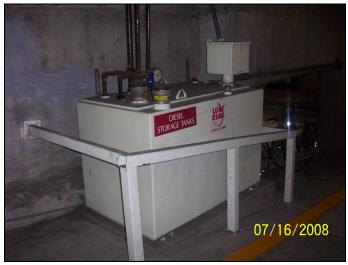
View of the diesel fuel storage tank for the emergency generator, located in the parking garage of the tower building, level #B-2; the tank is filled by extending the fuel line from the delivery truck through the freight elevator shaft and out and around the corner to the filler cap.

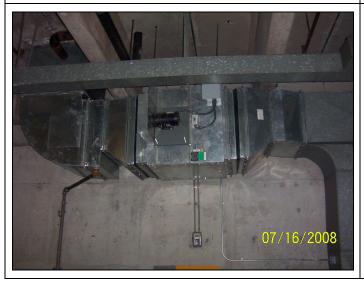
View of one of three typical parking garage exhaust fans mounted in-line with the ductwork at the tower building; the fan at the NW corner of the garage footprint runs continuously, while the other two cycle on and off.

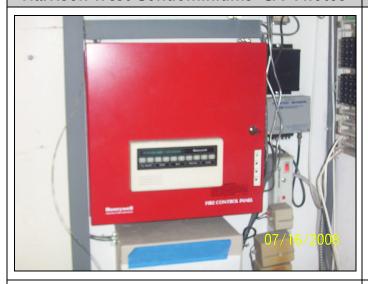
View of the fire control panel located in the fire sprinkler riser room adjacent to the parking garage in the tower building.

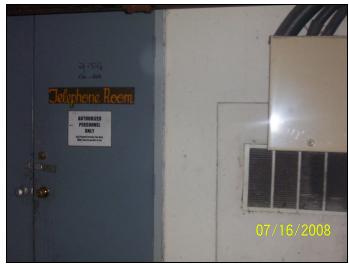
View of the communications room door; the door is locked by the utility.

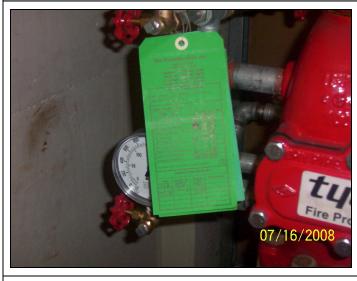
Close-up view of the inspection tag on the dry fire sprinkler riser, indicating the system was last inspected on April 14, 2008.

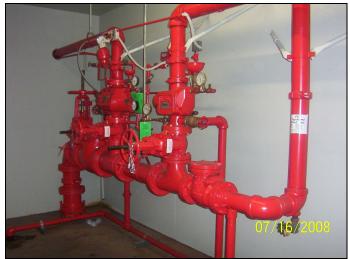
View of the wet fire sprinkler riser located in a room adjacent to the parking garage in the tower building.

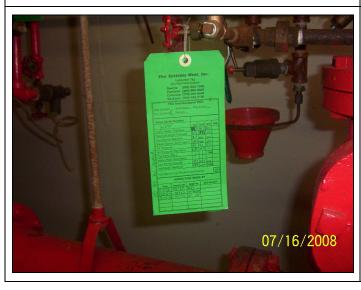
Close-up view of the inspection tag on the wet fire sprinkler riser indicating the system was last inspected on April 14, 2008.

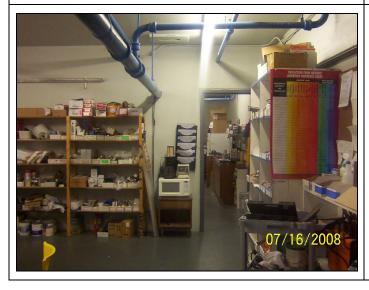
View of the maintenance staff office, looking into the shop area, located to the east; note the microwave and coffee maker.

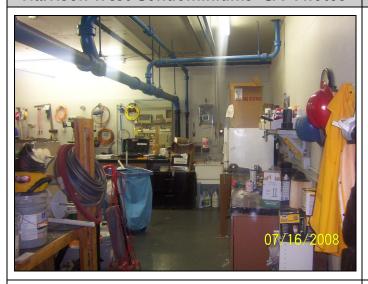
View of the maintenance shop located adjacent to the maintenance staff office, to the east, in the parking garage.

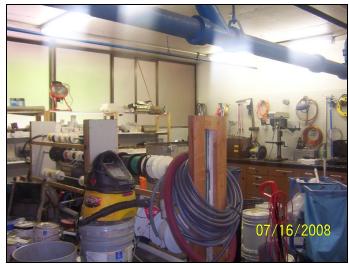
Another view of the maintenance shop located in the parking garage.

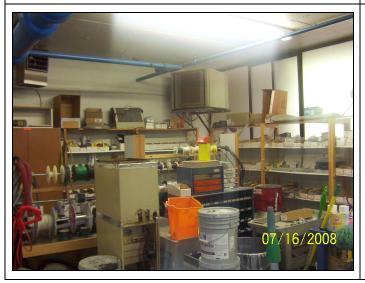
View of another electrical suspended space heater (at left side of photo) and a shelf-mounted air-conditioner (at right side of photo) in the maintenance shop located in the parking garage; the air conditioning condenser is located at the exterior, on a metal pan/curb on the other side of the wall.

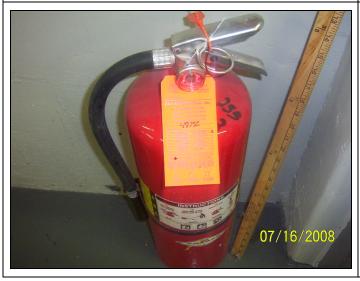
View of an ABC dry chemical fire extinguisher in the maintenance shop; this unit was last serviced in April, 2008.

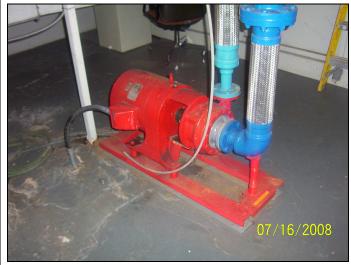
Close-up view of the 20-HP fire pump.

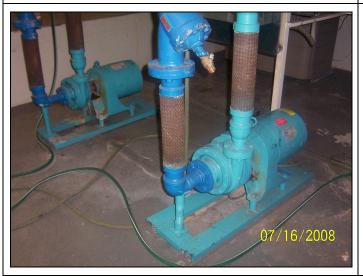
Close-up view of the high pressure domestic water supply line pumps; the closest one is 15-HP, the far one is 10-HP.

According to management, pumps are in good working order, but no spare pumps are in inventory and replacement pumps have a long-lead order time.

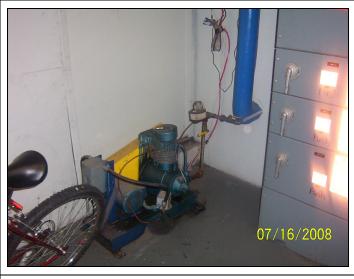
View of the compressor that supplies pressurized air to the parking garage sprinkler heads.

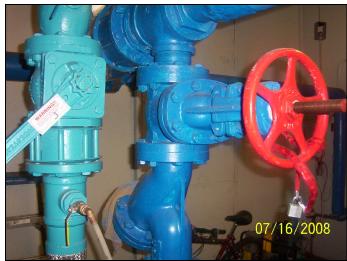
Close-up view of the red shut-off valve at the low pressure (dark blue) and light blue shut-off valve at the high pressure (light blue) domestic water supply lines.

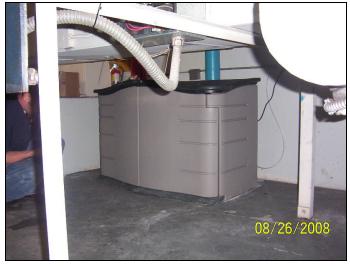
View of the water treatment system by Amnac, located in the mechanical room; the system treats water in the tower building above the fist floor; the townhouse buildings' water supply is not treated.
