| Harrison West Condominiums–CA–Photos | Exteriors & Sitework–Description |

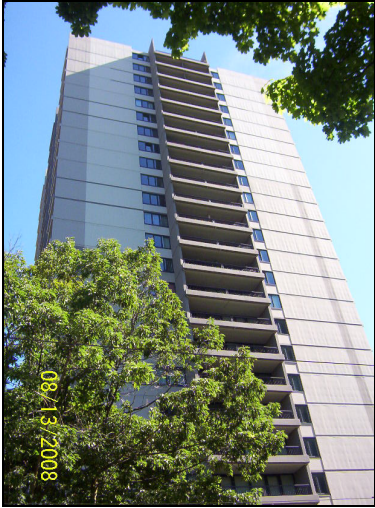
| Harrison West Condominiums–CA–Photos | Exteriors & Sitework–Description |
|---|---|
| | <p>View of the south façade of the tower building at the Subject Property, looking north.</p> |

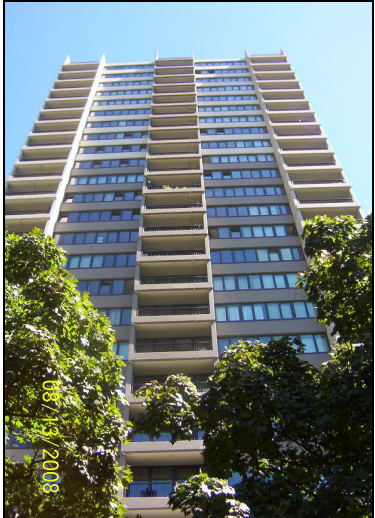
| Harrison West Condominiums–CA–Photos | Exteriors & Sitework–Description |
|---|---|
| | <p>View of the west façade of the tower building at the Subject Property, looking east.</p> |

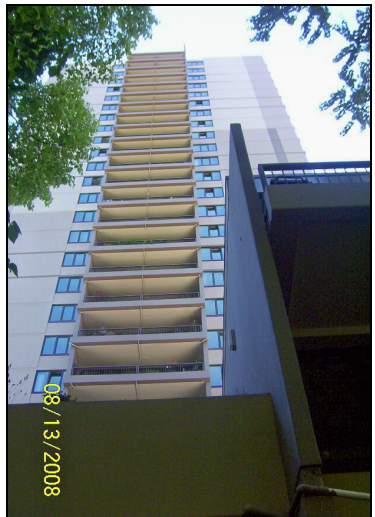
| Harrison West Condominiums–CA–Photos | Exteriors & Sitework–Description |
|---|---|
| | <p>View of the north façade of the tower building at the Subject Property, looking south.</p> |

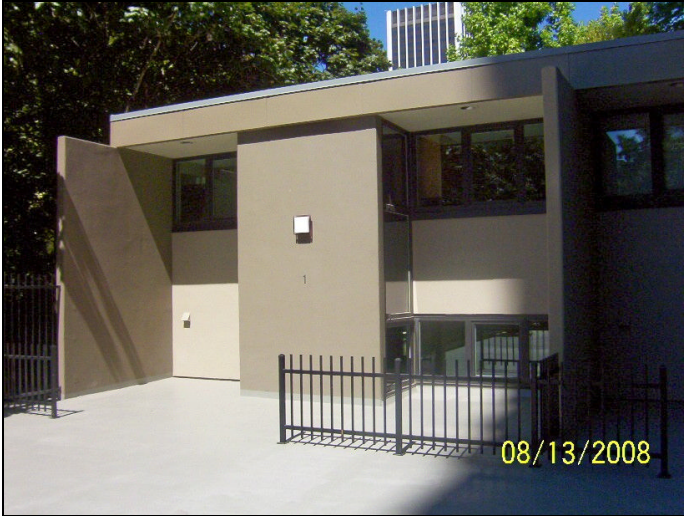
| Harrison West Condominiums-CA-Photos | Exteriors & Sitework-Description |
|---|--|
| | <p>View of the typical entry façade to the townhouse buildings at the Subject Property, this one is unit #1 at building #2, looking northwest.</p> |

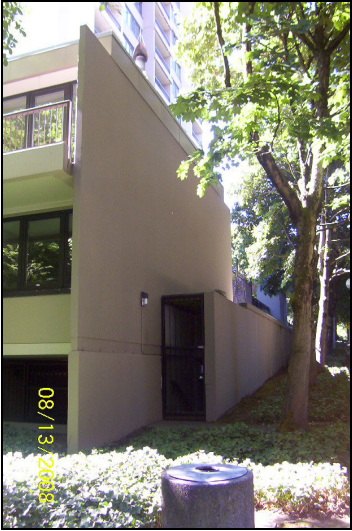
| Harrison West Condominiums–CA–Photos | Exteriors & Sitework–Description |
|---|---|
| | <p>View of the west façade of building #2 at the Subject Property, looking southeast.</p> |

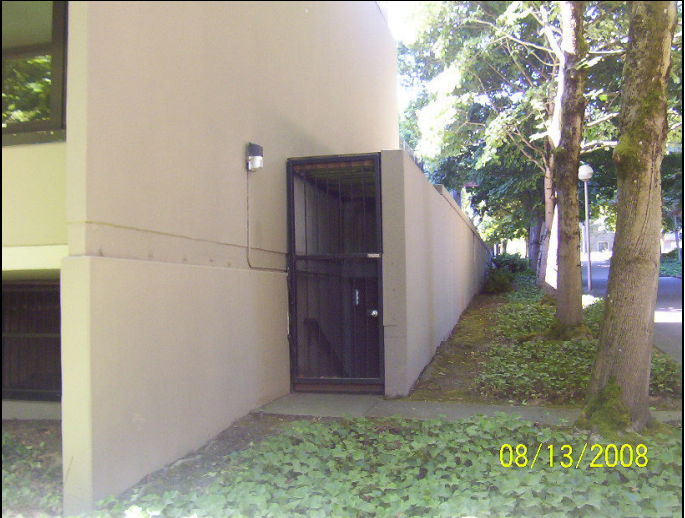
| Harrison West Condominiums–CA–Photos | Exteriors & Sitework–Description |
|---|---|
| | <p>Close-up view of the west façade of building #2 at the Subject Property, looking southeast at the northwest exit door from the parking garage.</p> |

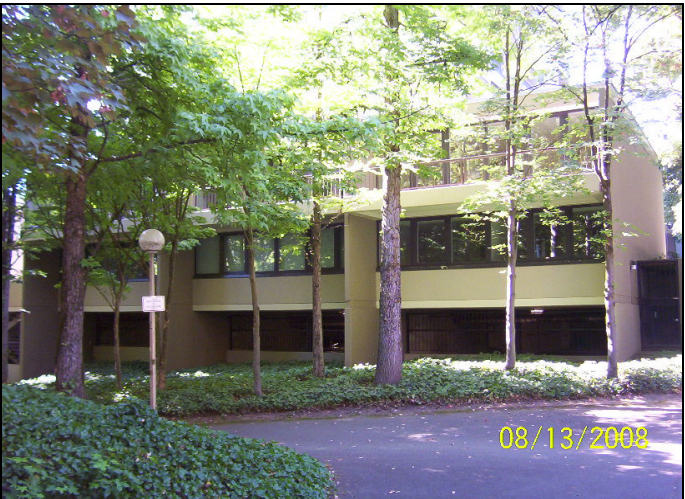
| Harrison West Condominiums–CA–Photos | Exteriors & Sitework–Description |
|---|---|
| | <p>View of the north façade of building #2 at the Subject Property, looking southeast.</p> |

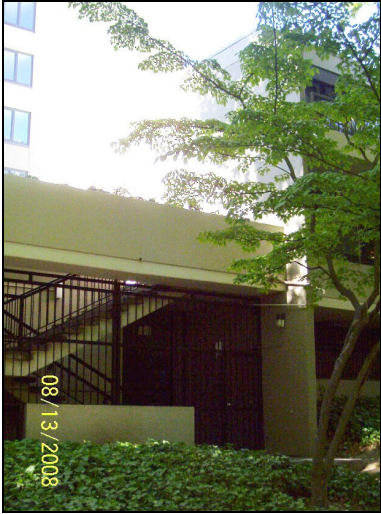
| Harrison West Condominiums-CA-Photos | Exteriors & Sitework-Description |
|---|--|
| | <p>View of the east façade of building #2 at the Subject Property, looking southwest.</p> |

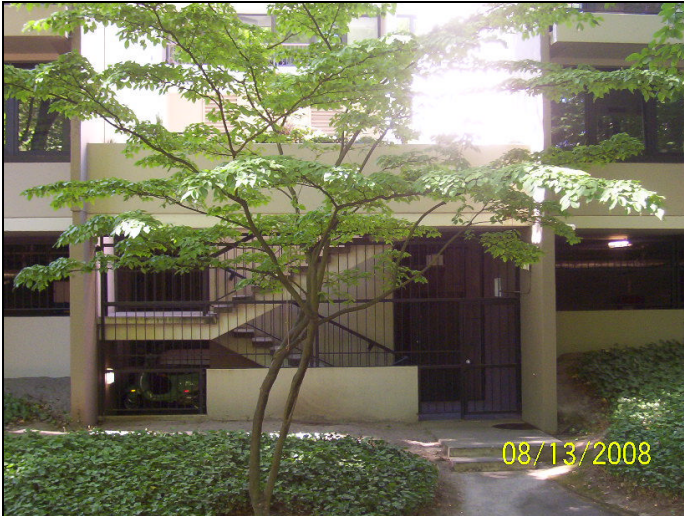
| Harrison West Condominiums-CA-Photos | Exteriors & Sitework-Description |
|---|--|
| | <p>View of the north-central exit door from the parking garage between buildings #2 &amp; #3 at the Subject Property, looking south.</p> |

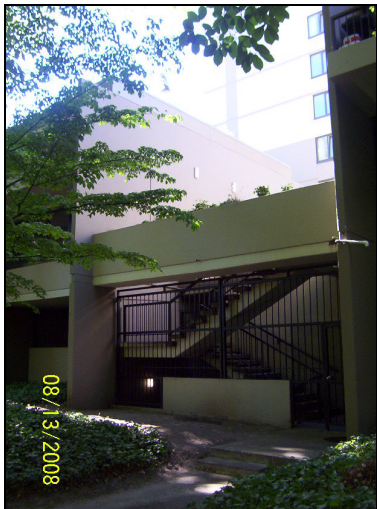
| Harrison West Condominiums-CA-Photos | Exteriors & Sitework-Description |
|---|--|
| | <p>View of the west façade of building #3 at the Subject Property, looking southeast.</p> |

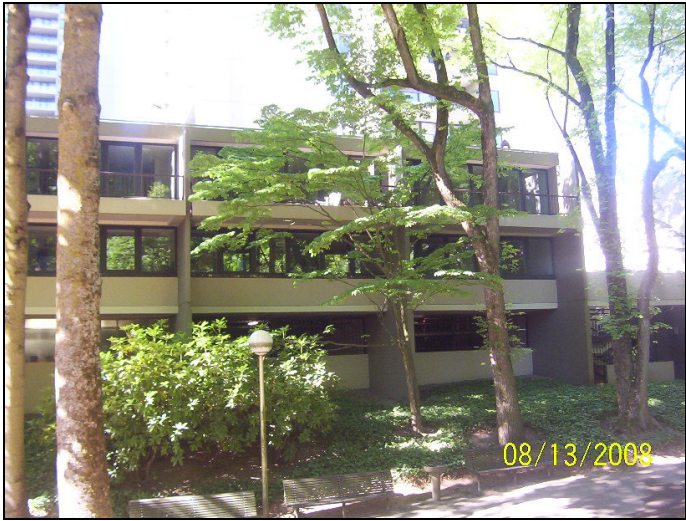
| Harrison West Condominiums-CA-Photos | Exteriors & Sitework-Description |
|---|--|
| | <p>View of the west end north façade of building #3 at the Subject Property, looking southwest.</p> |

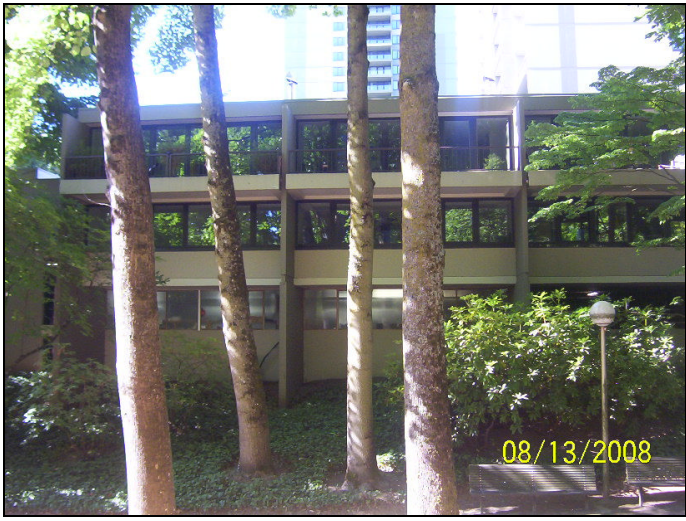
| Harrison West Condominiums-CA-Photos | Exteriors & Sitework-Description |
|---|--|
| | <p>View of the east end of the north façade of building #3 at the Subject Property, looking southwest.</p> |

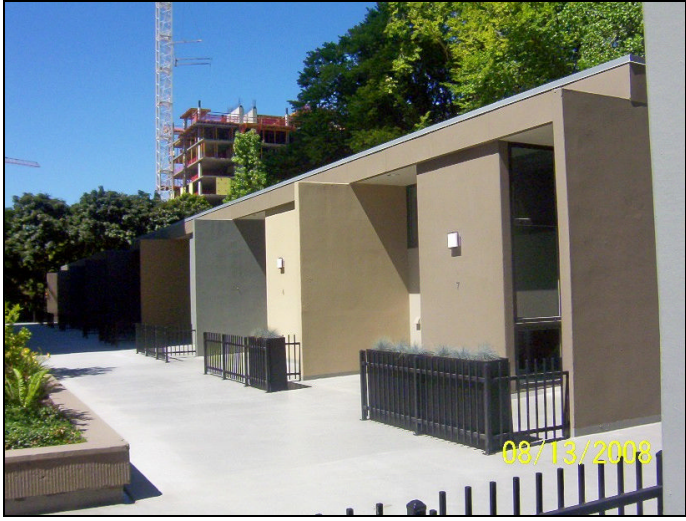
| Harrison West Condominiums-CA-Photos | Exteriors & Sitework-Description |
|---|--|
| | <p>View of the south façade of building #3, at the Subject Property, looking northwest.</p> |

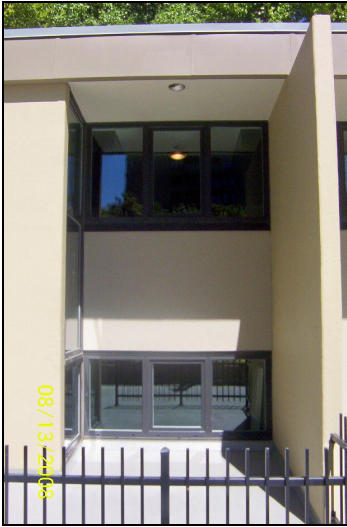
| Harrison West Condominiums-CA-Photos | Exteriors & Sitework-Description |
|---|---|
| | <p>View of the alcove opposite the entry door at building #3, unit #6 at the Subject Property, looking north.</p> |

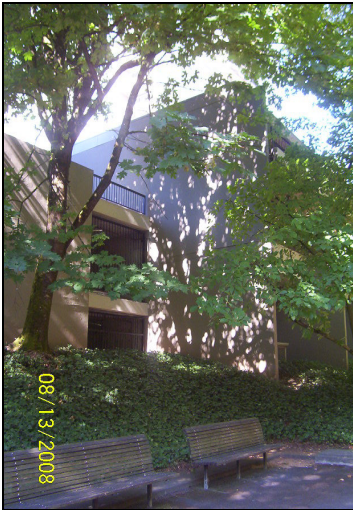
| Harrison West Condominiums-CA-Photos | Exteriors & Sitework-Description |
|---|---|
| | <p>View of the east facade of building #3 at the Subject Property, looking southwest.</p> |

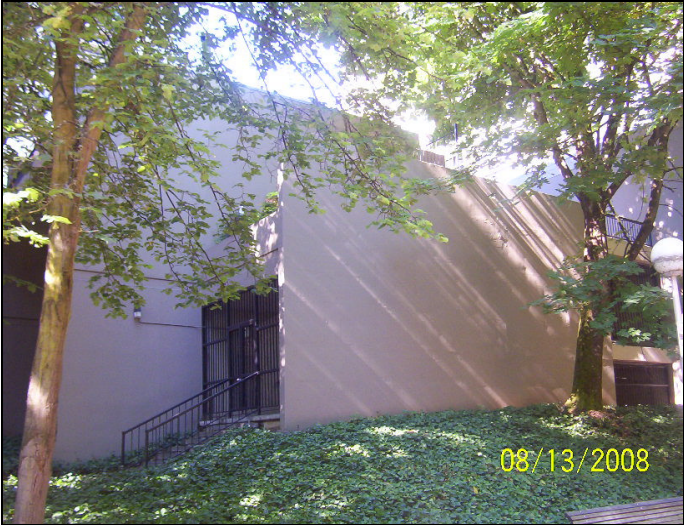
| Harrison West Condominiums-CA-Photos | Exteriors & Sitework-Description |
|---|---|
| | <p>View of the north facade of building #4 at the Subject Property, looking southwest.</p> |

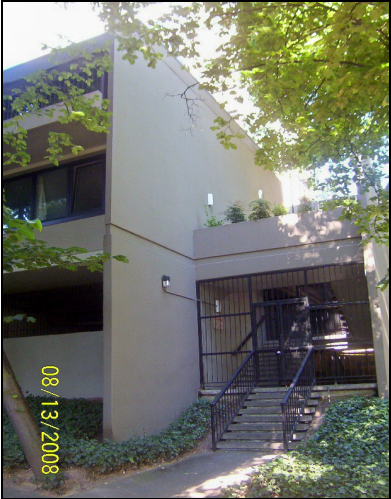
| Harrison West Condominiums-CA-Photos | Exteriors & Sitework-Description |
|---|---|
| | <p>View of the northeast exit door from the parking garage at the north facade of building #4 at the Subject Property, looking southwest.</p> |

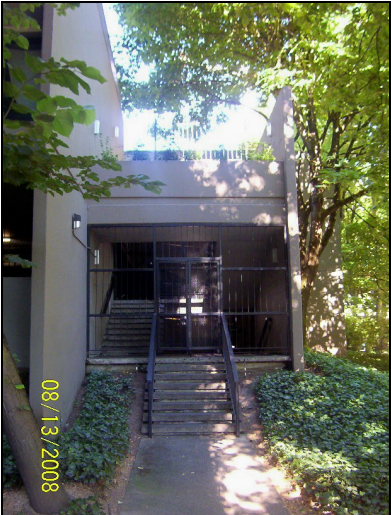
| Harrison West Condominiums-CA-Photos | Exteriors & Sitework-Description |
|---|---|
| | <p>Close-up view of the northeast exit door from the parking garage at the north facade of building #4 at the Subject Property, looking west.</p> |

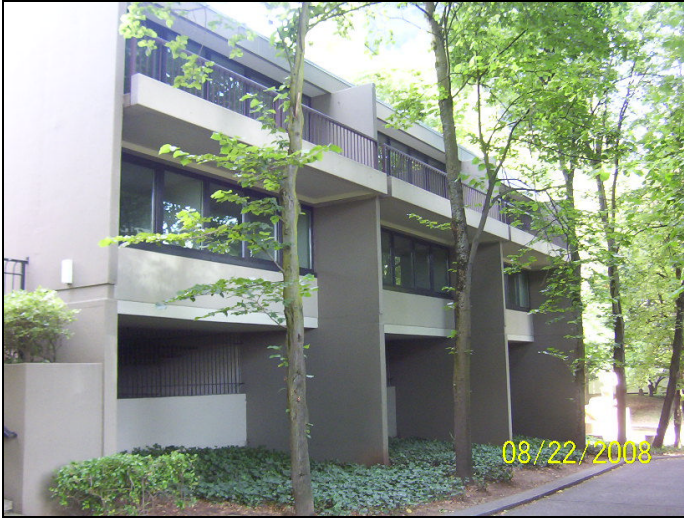
| Harrison West Condominiums-CA-Photos | Exteriors & Sitework-Description |
|---|--|
| | <p>View of the east façade of building #4 at the Subject Property, looking northwest.</p> |

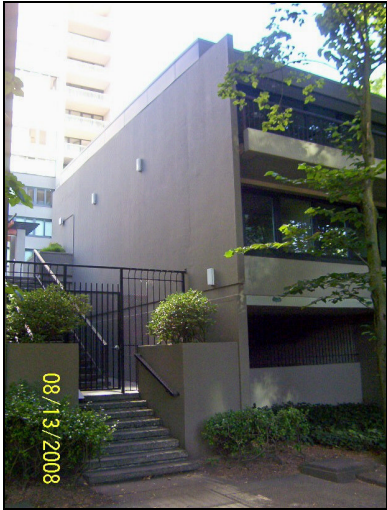
| Harrison West Condominiums-CA-Photos | Exteriors & Sitework-Description |
|---|--|
| | <p>View of the south façade of building #4 at the Subject Property, looking northwest.</p> |

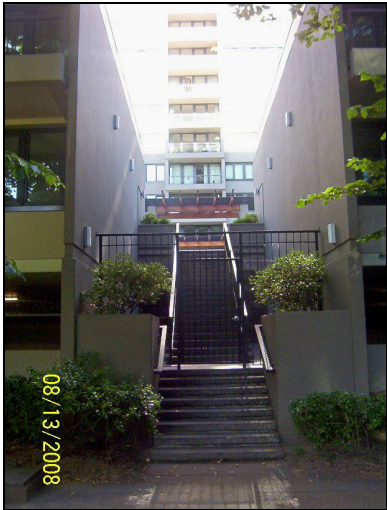
| Harrison West Condominiums-CA-Photos | Exteriors & Sitework-Description |
|---|--|
| | <p>View between buildings #4 &amp; #5 at the Subject Property, looking west.</p> |

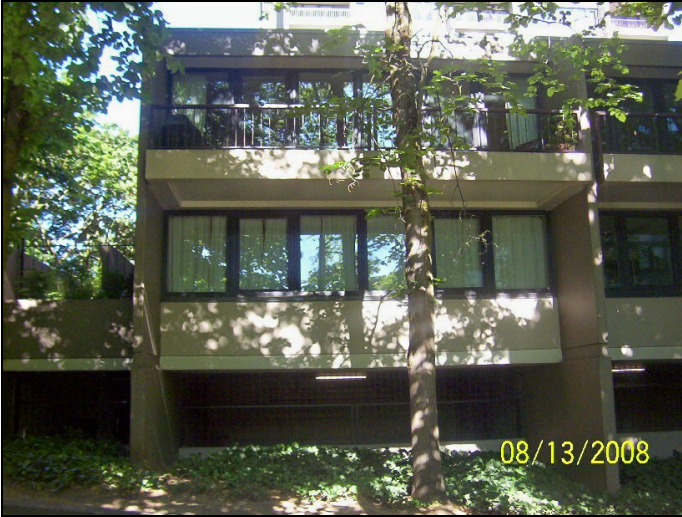
| Harrison West Condominiums-CA-Photos | Exteriors & Sitework-Description |
|---|--|
| | <p>View of the south end of the east façade of building #5 at the Subject Property, looking west.</p> |

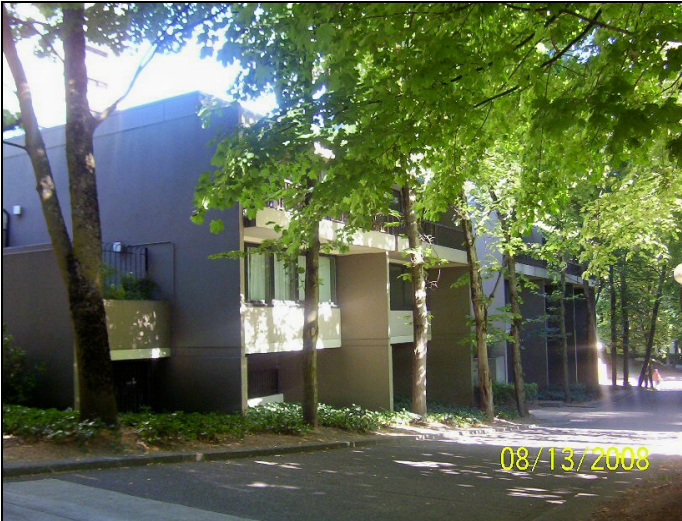
| Harrison West Condominiums-CA-Photos | Exteriors & Sitework-Description |
|---|--|
| | <p>View of the southeast façade of building #5 at the Subject Property, looking northwest.</p> |

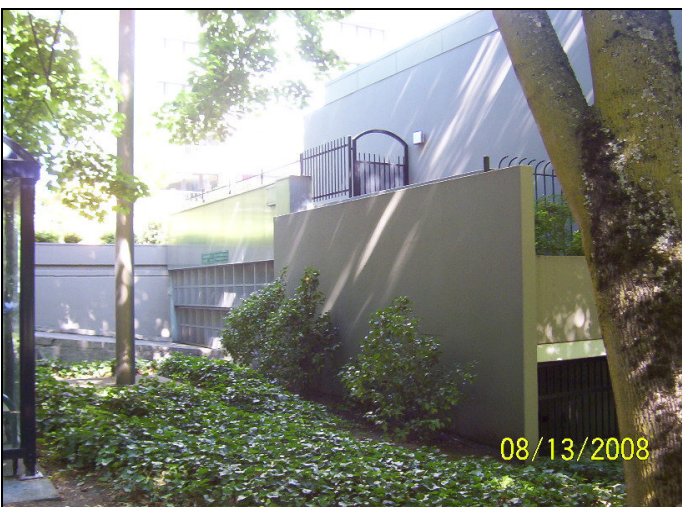
| Harrison West Condominiums-CA-Photos | Exteriors & Sitework-Description |
|---|--|
| | <p>View of the south façade of building #5 at the Subject Property, looking northwest; this is the southeast exit staircase from the parking garage.</p> |

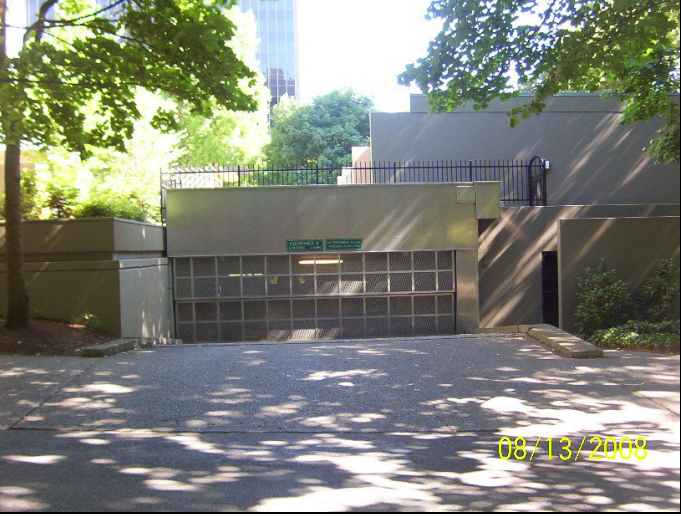
| Harrison West Condominiums-CA-Photos | Exteriors & Sitework-Description |
|---|--|
| | <p>View of the parking garage entrance located between the tower, building #1, and the townhouse, building #5, at the Subject Property, looking north.</p> |

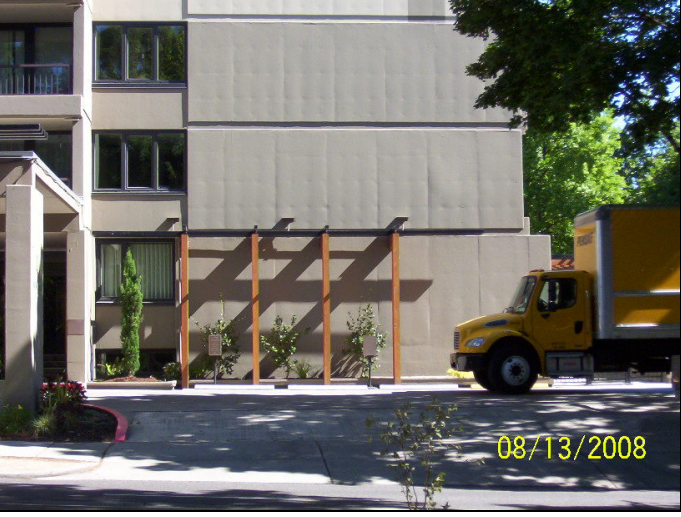
| Harrison West Condominiums-CA-Photos | Exteriors & Sitework-Description |
|---|--|
| | <p>View of the east side of the porte cochere and the trellis in front of the visitor parking stalls; the freight elevator loading area is out of the picture, to the right.</p> |

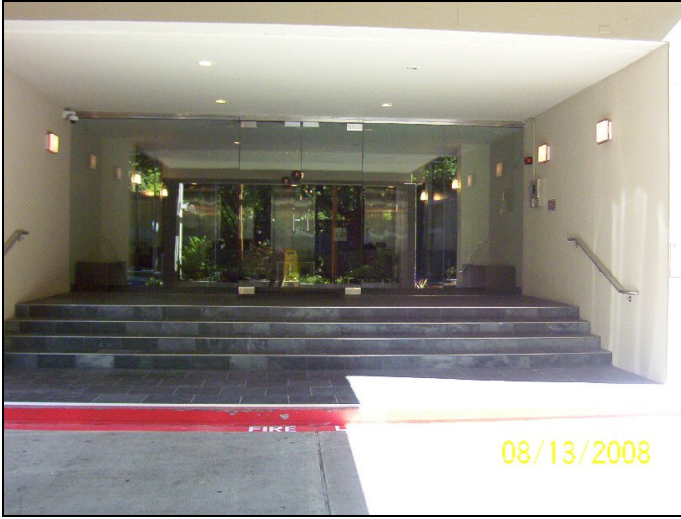
| Harrison West Condominiums-CA-Photos | Exteriors & Sitework-Description |
|---|---|
| | <p>View of the main entrance to the lobby at the tower, building #1.</p> |

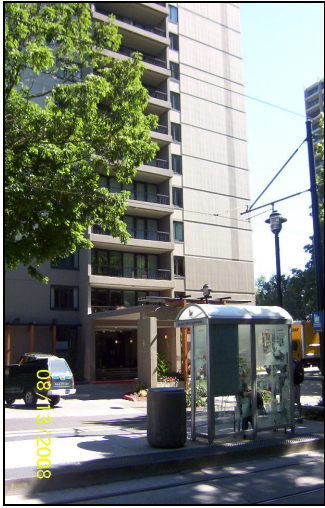
| Harrison West Condominiums-CA-Photos | Exteriors & Sitework-Description |
|---|---|
| | <p>View of the west side of the porte cochere at the tower building main entrance and the trellis in front of the visitor parking stalls, at the west side.</p> |

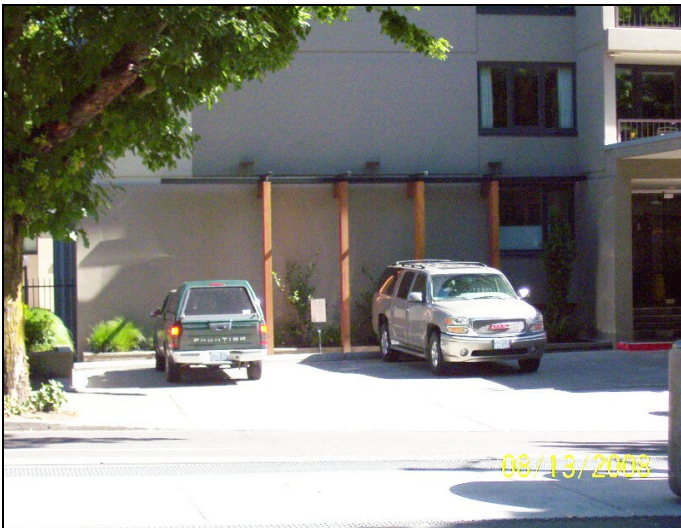
| Harrison West Condominiums-CA-Photos | Exteriors & Sitework-Description |
|---|---|
| | <p>View of the trellis in front of the visitor parking stalls, at the west side of the porte cochere at the tower building main entrance.</p> |

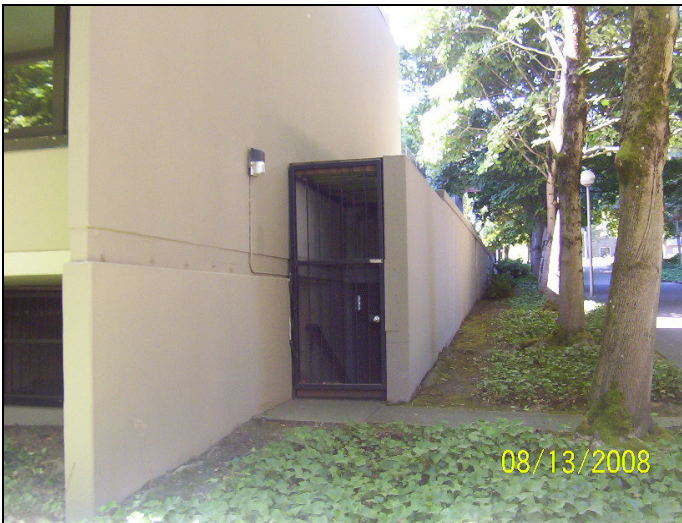
| Harrison West Condominiums-CA-Photos | Exteriors & Sitework-Description |
|---|--|
| | <p>Close-up view to the northwest exit gate from the parking garage.</p> |

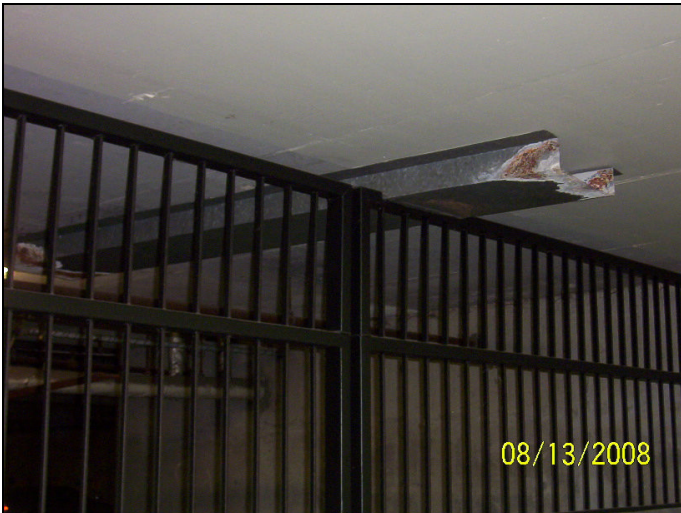
| Harrison West Condominiums-CA-Photos | Exteriors & Sitework-Description |
|---|--|
| <p style="text-align: right; color: yellow;">08/13/2008</p> | <p>View of an exhaust duct surface applied to the parking garage soffit below unit #3, building #2.</p> |

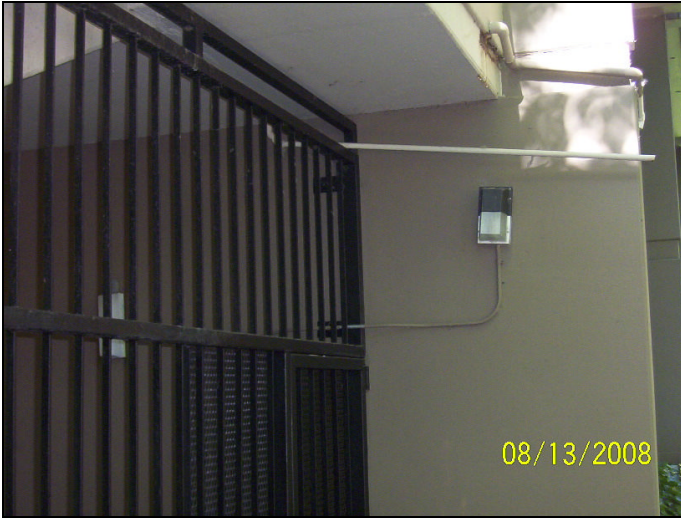
| Harrison West Condominiums-CA-Photos | Exteriors & Sitework-Description |
|---|--|
| <p style="text-align: right; color: yellow;">08/13/2008</p> | <p>View of the typical pedestrian light fixtures at the plaza and parking garage exit doors, this at the east end of building #2.</p> |

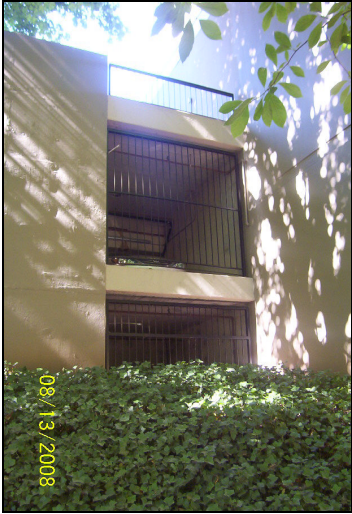
| Harrison West Condominiums-CA-Photos | Exteriors & Sitework-Description |
|---|---|
| <p>08/13/2008</p> | <p>View of the typical painted metal security grilles at the parking garage openings.</p> |

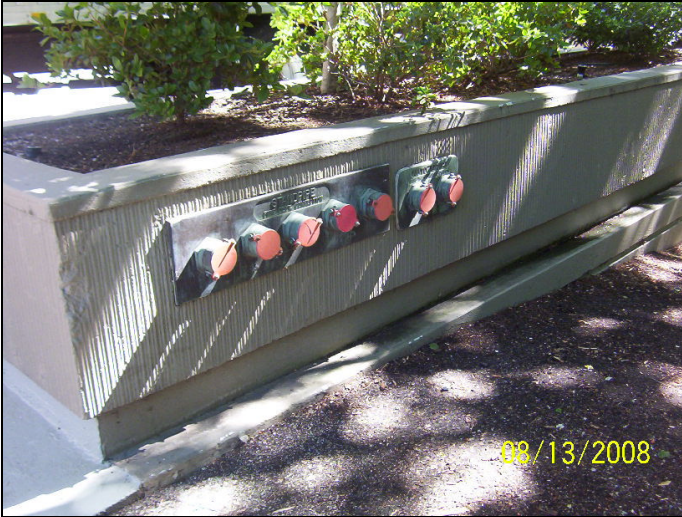
| Harrison West Condominiums-CA-Photos | Exteriors & Sitework-Description |
|---|--|
| | <p>View of the fire department hose connections at the planter adjacent to the porte cochere driveway at SW Harrison Street, at the east side.</p> |

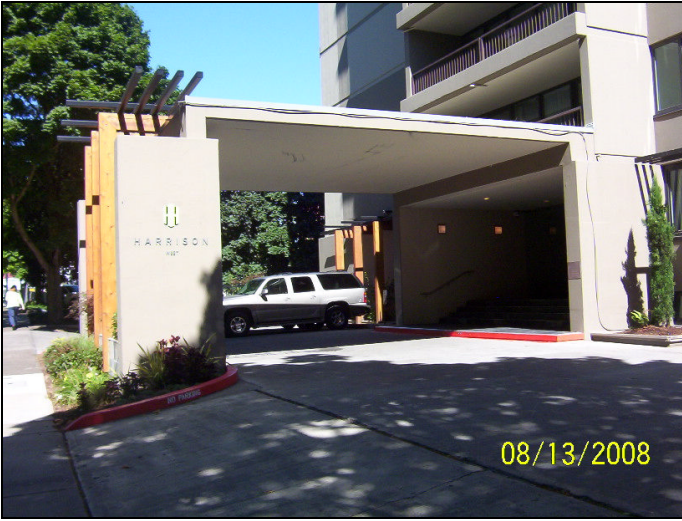
| Harrison West Condominiums-CA-Photos | Exteriors & Sitework-Description |
|---|--|
| | <p>View of the driveway through the porte cochere at the tower, building #1.</p> |

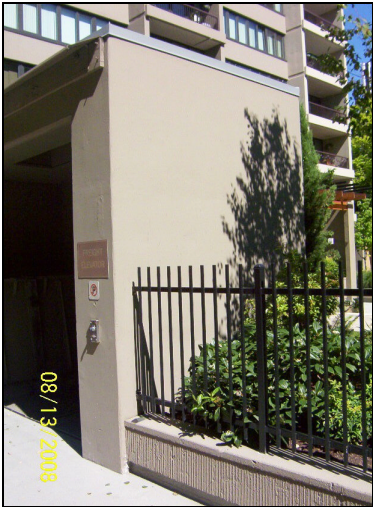
| Harrison West Condominiums-CA-Photos | Exteriors & Sitework-Description |
|---|--|
| | <p>View of the east wall of the freight elevator, adjacent to the porte cochere at the tower, building #1.</p> |

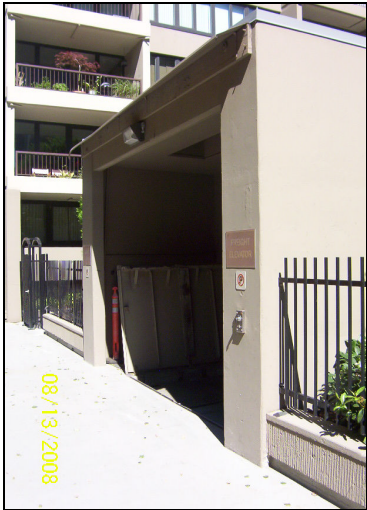
| Harrison West Condominiums-CA-Photos | Exteriors & Sitework-Description |
|---|---|
| | <p>View of the south wall opening of the freight elevator, adjacent to the porte cochere at the tower, building #1.</p> |

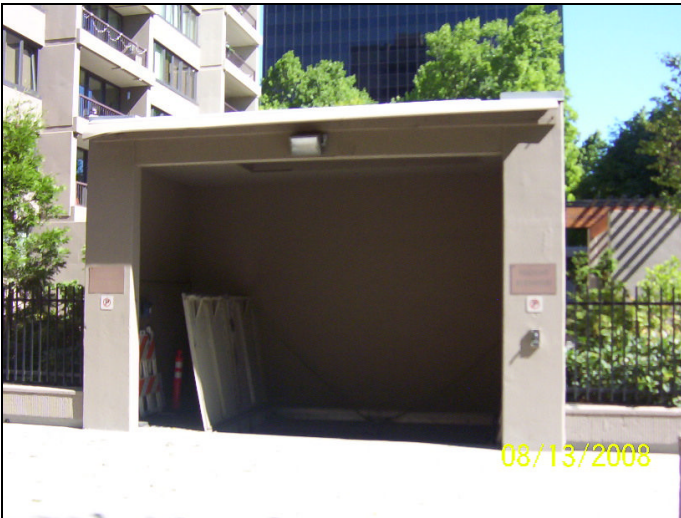
| Harrison West Condominiums-CA-Photos | Exteriors & Sitework-Description |
|---|---|
| | <p>Another view of the south wall opening of the freight elevator, adjacent to the porte cochere at the tower, building #1.</p> |

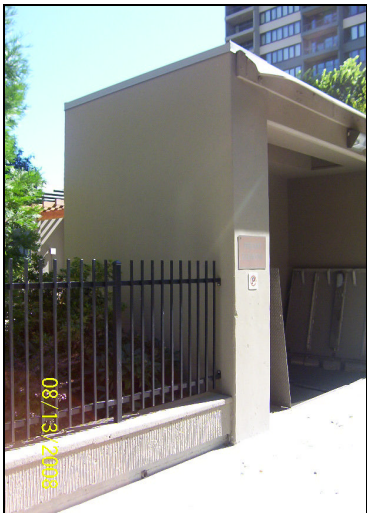
| Harrison West Condominiums-CA-Photos | Exteriors & Sitework-Description |
|---|---|
| | <p>View of the west wall of the freight elevator, adjacent to the porte cochere at the tower, building #1.</p> |

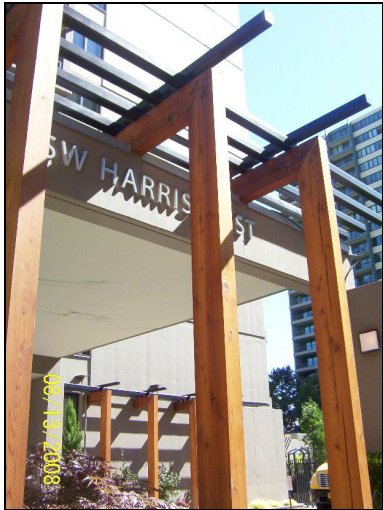
| Harrison West Condominiums-CA-Photos | Exteriors & Sitework-Description |
|---|---|
| | <p>Close-up view of the address sign at the south side of the porte cochere at the main entrance into the tower, building #1.</p> |

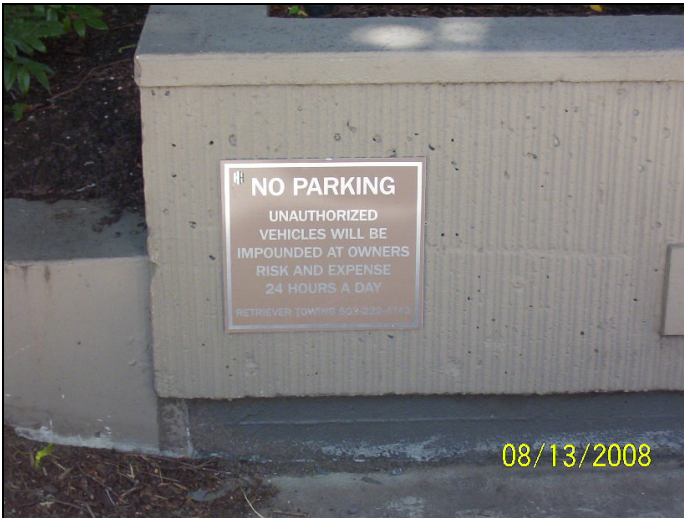
| Harrison West Condominiums-CA-Photos | Exteriors & Sitework-Description |
|---|---|
| | <p>View of the typical fixed metal sign plaques at the Subject Property.</p> |

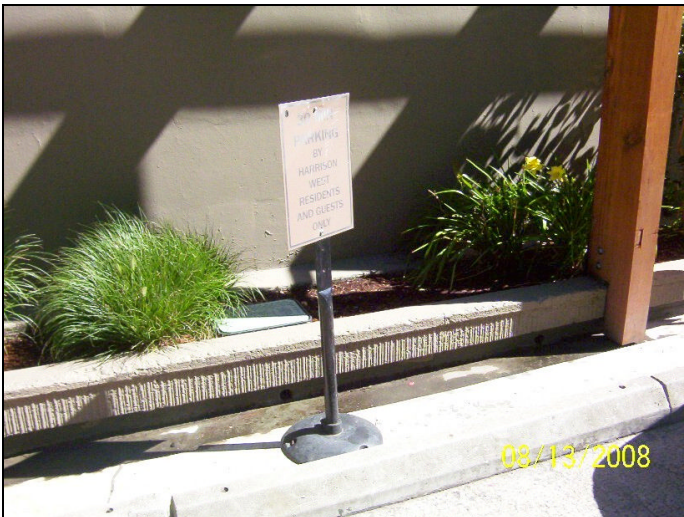
| Harrison West Condominiums-CA-Photos | Exteriors & Sitework-Description |
|---|---|
| | <p>View of the typical free-standing metal sign plaque at the Subject Property.</p> |

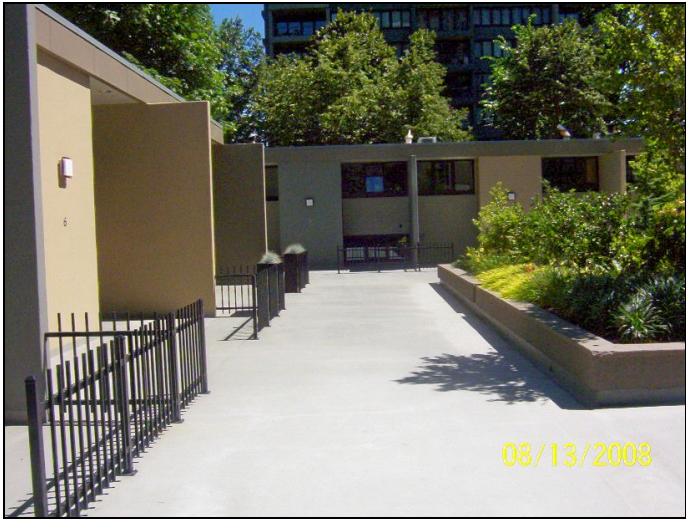
| Harrison West Condominiums-CA-Photos | Exteriors & Sitework-Description |
|---|---|
| | <p>View of the north plaza adjacent to townhouse buildings #3 &amp; #4, looking east.</p> |

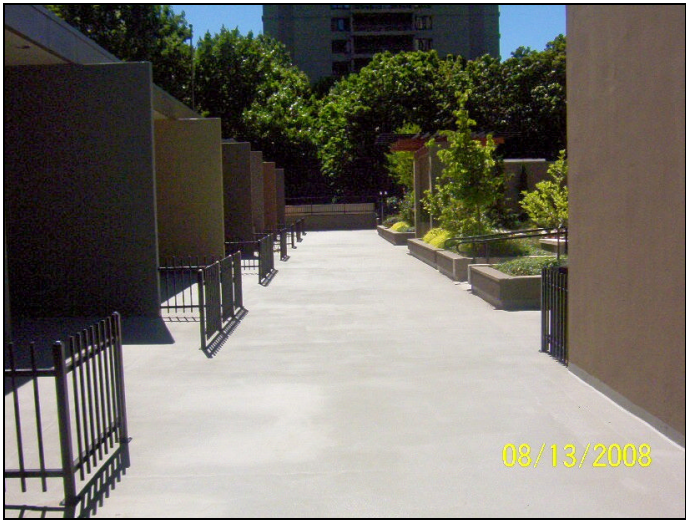
| Harrison West Condominiums-CA-Photos | Exteriors & Sitework-Description |
|---|---|
| | <p>View of the east plaza adjacent to townhouse buildings #4 &amp; #5, looking south.</p> |

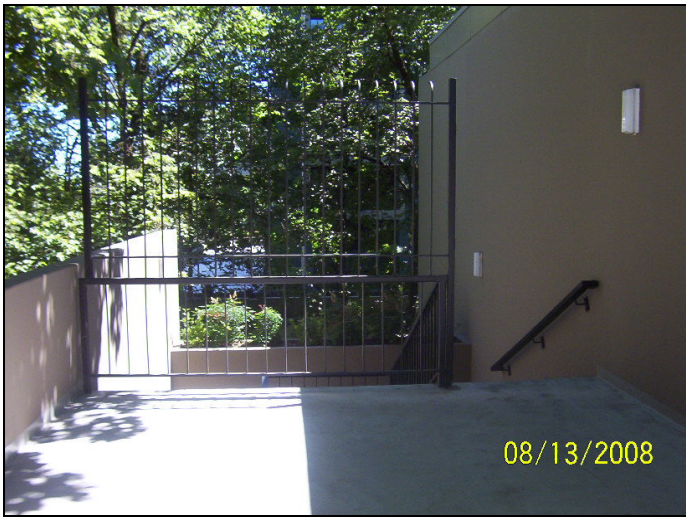
| Harrison West Condominiums-CA-Photos | Exteriors & Sitework-Description |
|---|---|
| | <p>View of the northeast exit staircase from the east plaza, looking east.</p> |

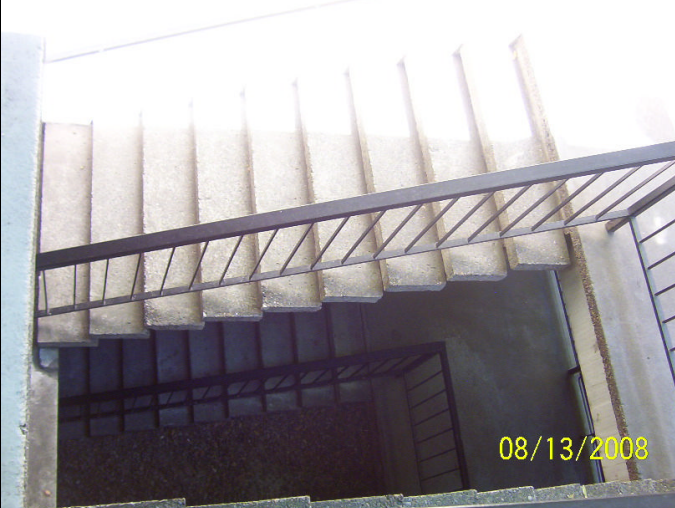
| Harrison West Condominiums-CA-Photos | Exteriors & Sitework-Description |
|---|---|
| <p>08/13/2008</p> | <p>View of the northeast exit staircase from the east plaza, looking down.</p> |

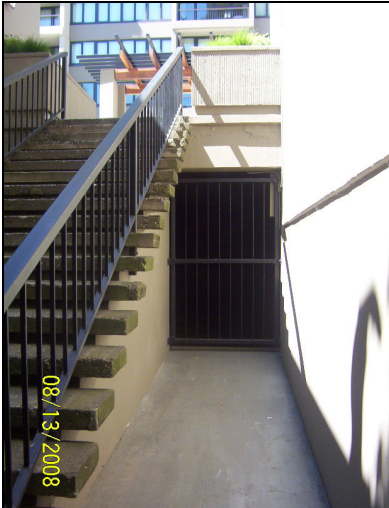
| Harrison West Condominiums-CA-Photos | Exteriors & Sitework-Description |
|---|---|
| | <p>View of the exit staircase from the plaza between buildings #4 &amp; #5, looking west; the security grille on this side is fixed.</p> |

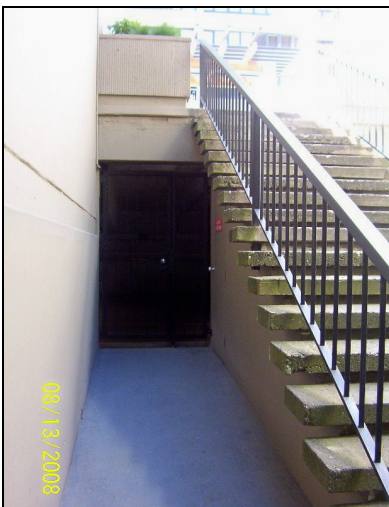
| Harrison West Condominiums-CA-Photos | Exteriors & Sitework-Description |
|---|---|
| | <p>View of the exit staircase from the plaza between buildings #4 &amp; #5, looking west; the security grille on this side is an operable gate to the parking garage.</p> |

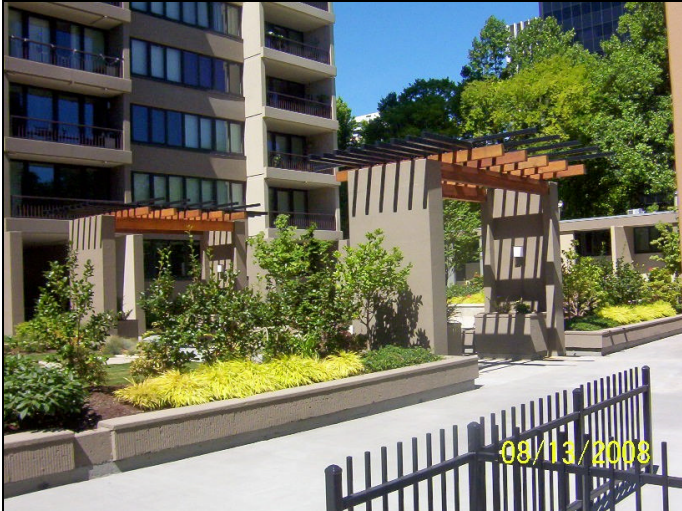
| Harrison West Condominiums-CA-Photos | Exteriors & Sitework-Description |
|---|--|
| | <p>View of the wood trellises and raised planters at the east plaza, looking northwest.</p> |

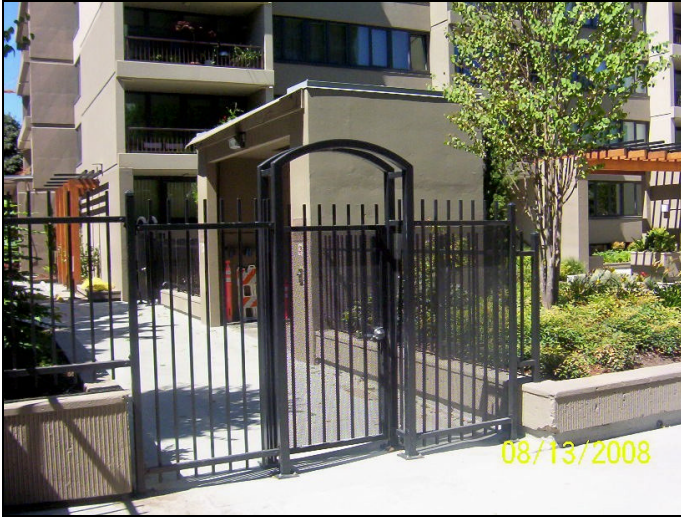
| Harrison West Condominiums-CA-Photos | Exteriors & Sitework-Description |
|---|--|
| <p>08/13/2008</p> | <p>View of the plaza entry gate at the southeast corner; note the freight elevator enclosure beyond.</p> |

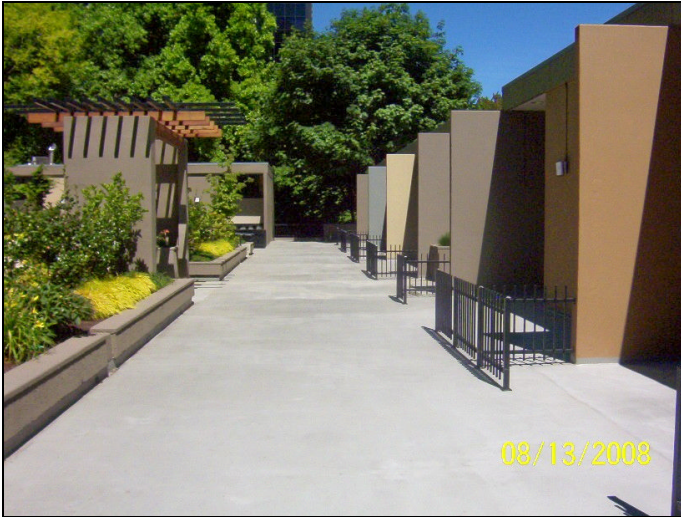
| Harrison West Condominiums-CA-Photos | Exteriors & Sitework-Description |
|---|--|
| <p>08/13/2008</p> | <p>View of the east plaza along the townhouse buildings #5 &amp; #4, looking north.</p> |

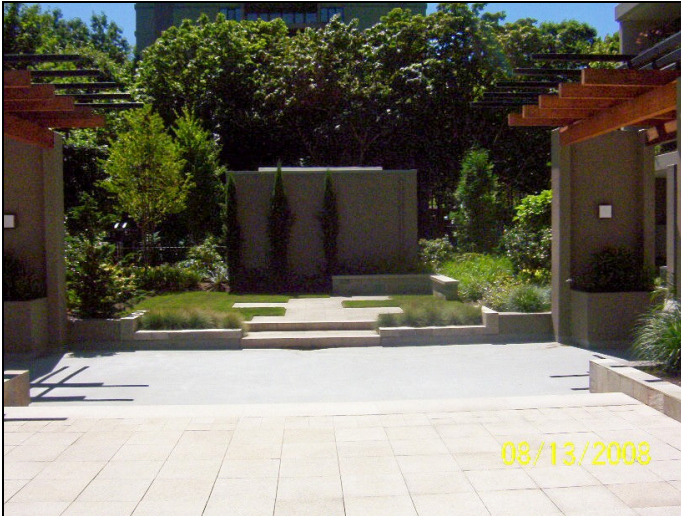
| Harrison West Condominiums-CA-Photos | Exteriors & Sitework-Description |
|---|--|
| <p>08/13/2008</p> | <p>View of the east plaza between trellises, looking south.</p> |

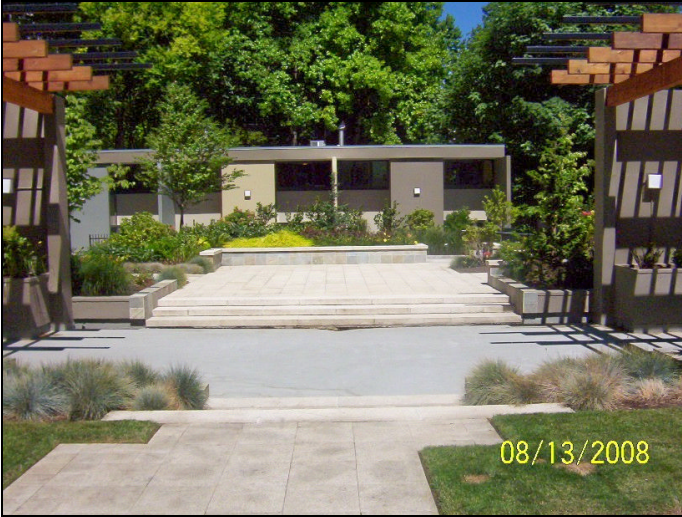
| Harrison West Condominiums-CA-Photos | Exteriors & Sitework-Description |
|---|--|
| | <p>View of the east plaza between trellises, looking north toward building #3.</p> |

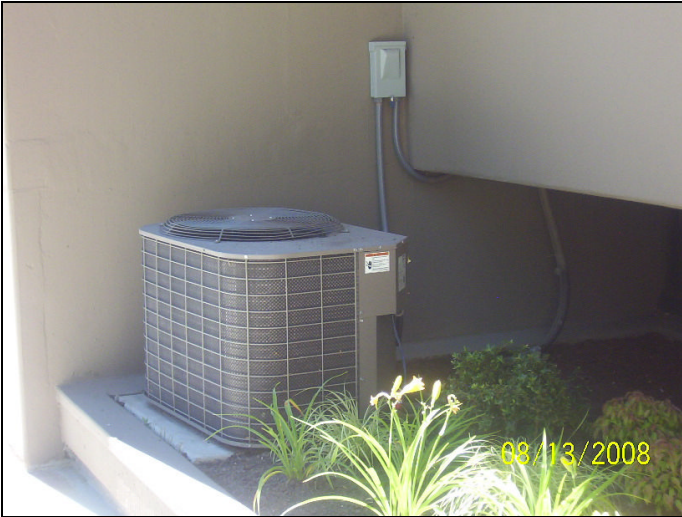
| Harrison West Condominiums-CA-Photos | Exteriors & Sitework-Description |
|---|--|
| | <p>View of an air conditioning compressor located in the planter at the east plaza area.</p> |

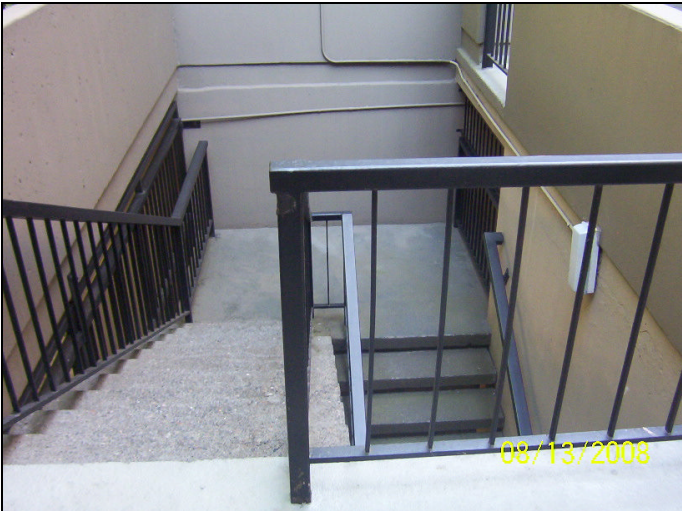
| Harrison West Condominiums-CA-Photos | Exteriors & Sitework-Description |
|---|--|
| | <p>View of the exit staircase from the north plaza between buildings #1 &amp; #2, looking north.</p> |

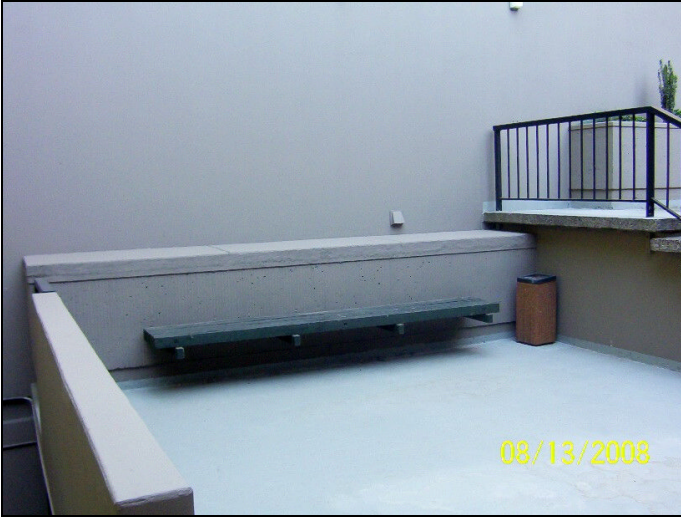
| Harrison West Condominiums-CA-Photos | Exteriors & Sitework-Description |
|---|--|
| | <p>View of the sitting area adjacent to the exit staircase from the north plaza between buildings #1 &amp; #2, looking east.</p> |
