LEVEL 1
RESERVE STUDY
FOR
HARRISON WEST CONDOMINIUMS
OWNERS ASSOCIATION
(Current Assessment Funding Model)

January 1, 2009 - December 31, 2009

Harrison West Condominiums

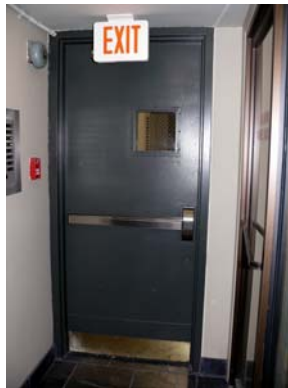
Common Area Doors/Metal - Partial Replacement - 2024

Partial replacement funding for metal doors located throughout common areas of building 1 and the parking garage. Replacement of the door and hardware is assumed. Typical hardware package includes locking handle; 1-1/2 pair of ball-bearing hinges; hydraulic surface mounted door closer.

Replacement of the door frames is not included in the cost estimate.

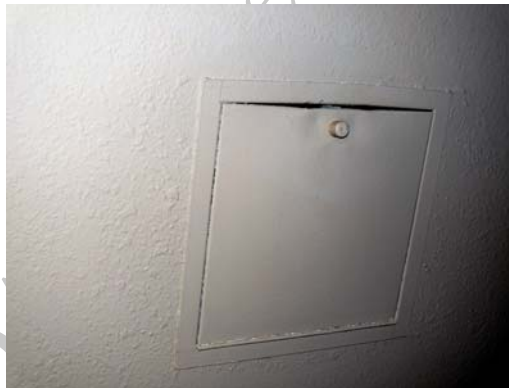
Milcor Fire-Rated Access Doors - Replacement - 2010

Partial replacement funding for replacement of the plumbing access doors located in the corridors of building 1. Replacement of 50% of the existing doors is assumed.

Condition: Poor to Fair

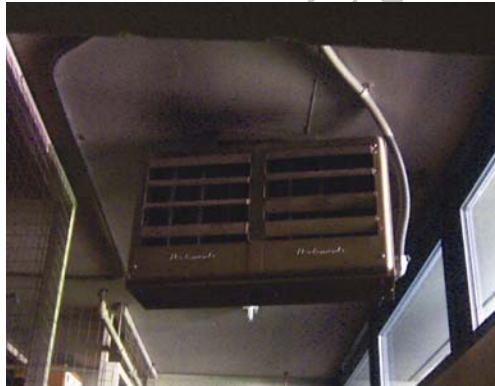
Electric Space Heaters - Replacement - 2024

Replacement funding for the electric space heaters located in the maintenance shop, laundry room and storage locker areas.

Condition: Good

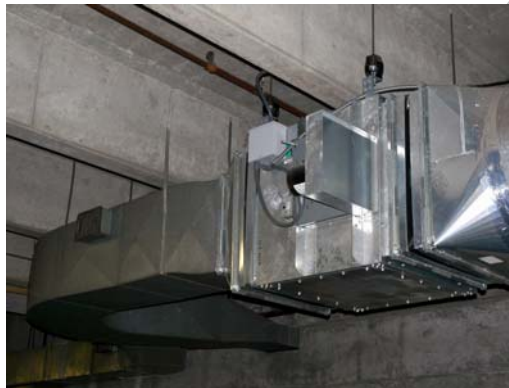
Exhaust Fans - Parking Garage - Replacement - 2032

Replacement funding for the parking garage in-line exhaust fans.

Condition: Good

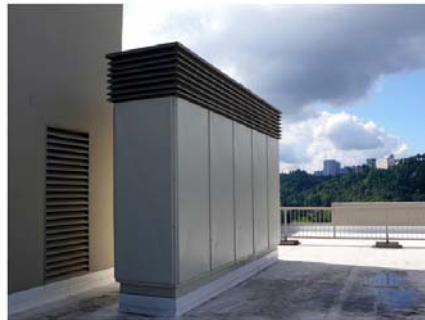
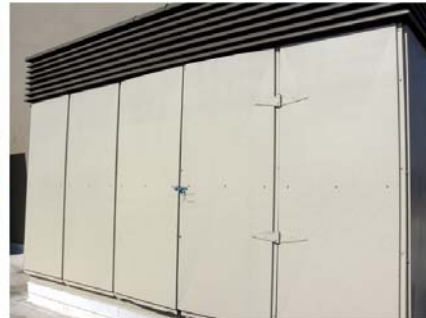
Rooftop Exhaust Fans - Bldg. 1 - Replacement - 2032

Funding contingency for replacement of the exhaust fans and controls which are located on the roof of building 1. These fans exhaust stale interior air from building 1 and the elevator equipment room.

Condition: Good

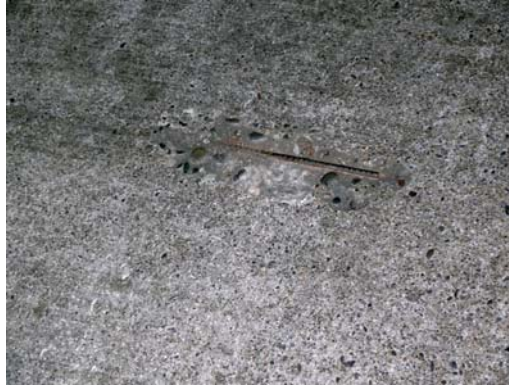
Concrete Pavement - Parking Garage - Repair continued...

Partial replacement funding for concrete pavement throughout the parking garage. Includes cost of concrete pumping.

Condition: Fair

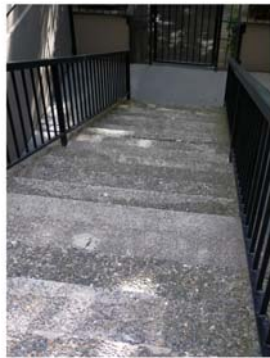
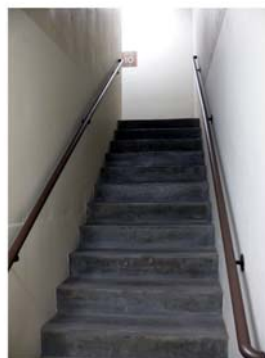
Concrete Stairs & Landings - Repairs - 2010

Repair contingency for concrete stairs located throughout the exterior of the property.

Condition: Poor to Fair

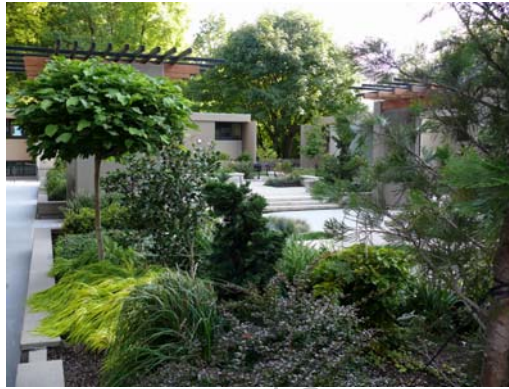
Landscaping - Plant Replacement - 2016

Funding allowance for replacement of ornamental landscaping located throughout the property. Replacement of dead, diseased and outdated landscaping should be anticipated periodically.

Condition: Good

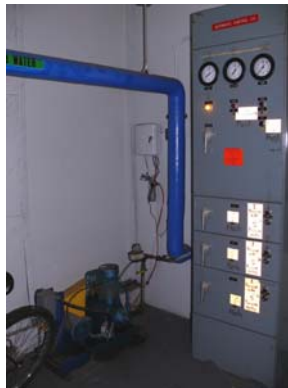
Booster Pumps/Controls & Switches - Replacement - 2017

Replacement funding for booster pump controls and switches. A total of three pumps are used in the fresh water supply and fire suppression systems.

Condition: Good

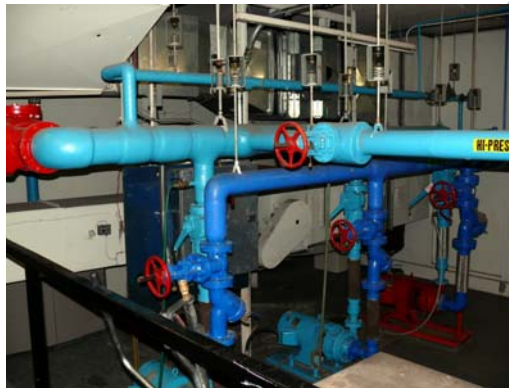
Booster Pumps/Water Supply System - Rebuild - 2017

Funding for rebuilding the water supply booster pumps. A total of three pumps are used in the fresh water supply and fire suppression systems; 2-15HP & 1-20HP.

Condition: Good

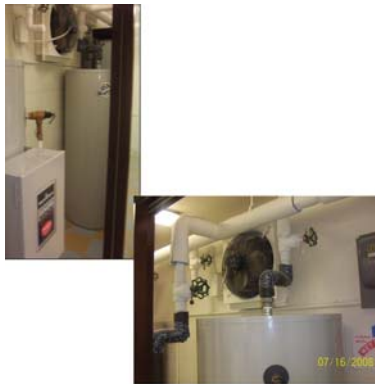
Electric Water Heaters/Laundry Room - Replacement - 2021

Replacement funding for two Bradford-White 119 gallon electric water heaters located in the laundry room.

Condition: Good

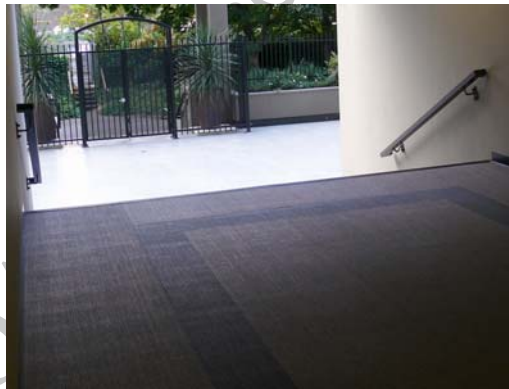
Flooring Replacement/Woven Vinyl - Breezeways - 2021

Funding for the periodic replacement of the woven vinyl flooring located in the 1st floor breezeways of building 1.

Condition: Good

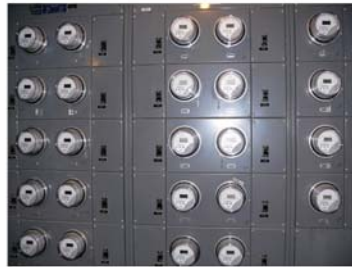
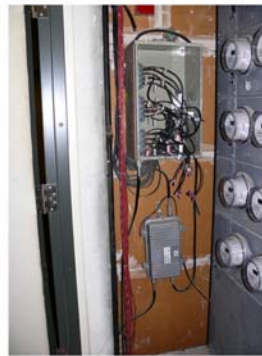
Funding contingency for replacement of electrical system components, including, but not limited to branch wiring, switchgear, meter equipment and unit sub-panels.

Condition: Good

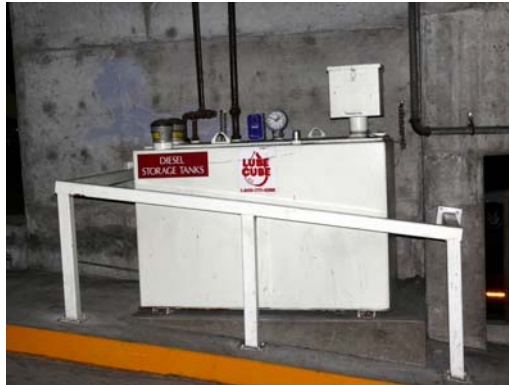
Emergency Power Generator/Fuel Tank - Replacement continued...

Replacement funding for the diesel fuel storage tank located in the parking garage. This tank provides fuel storage for the emergency power generator.

Condition: Good
